Access Compliance Report

Public Rights-of-Way

(Curb Ramps)

Intersection ID: 29515	Main Street: ROSS_MOORE_AV	Cross Street: SILABERT_AV	Location: NE
ADA ID: BB7F61309530	Ramp Type: PerpDiag	Initial Pass/Fail: Fail	Overall Compliance: No
Severity Score: 21.25			
Codes/Mitigation Info/Possible Solution		Field Measurements/Component Compliance

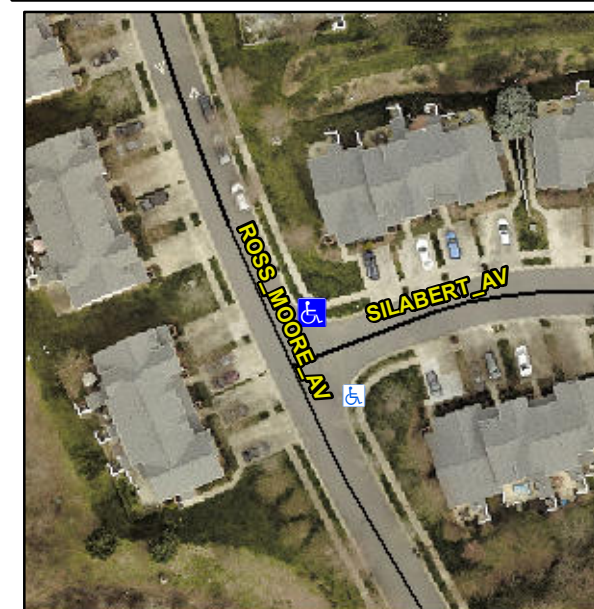
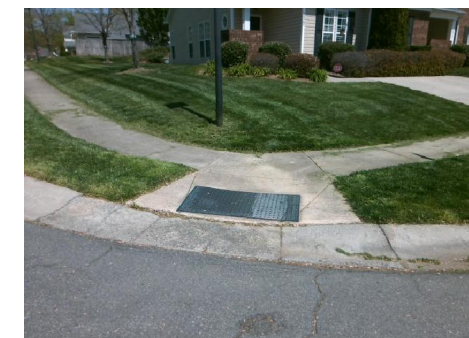
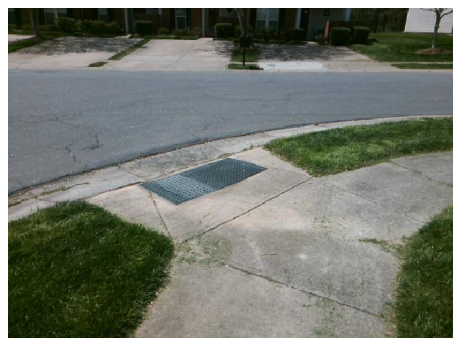
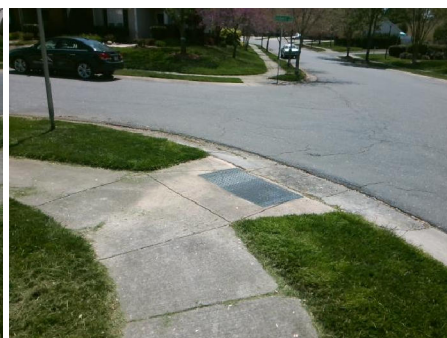
Compliance	Description	Data	Compliance	Description	Data
N/A	Ramp Length (in)	48.0	Yes	Ramp Slope (%)	5.3
No	Ramp Width (in)	41.5	No	Ramp XSlope (%)	6.2
N/A	Flare Type LT	N/A	N/A	Flare Type RT	N/A
N/A	Flare Slope LT (%)	N/A	N/A	Flare Slope RT (%)	N/A
N/A	Flare Traversable LT?	N/A	N/A	Flare Traversable RT?	N/A
N/A	Landing Length (in)	N/A	N/A	DWS Provided?	N/A
N/A	Landing Width (in)	N/A	N/A	DWS Contrast?	N/A
N/A	Landing Slope (%)	N/A	N/A	DWS Length (in)	N/A
N/A	Landing X Slope (%)	N/A	N/A	DWS Full Width?	N/A
N/A	Landing Curb? (Y/N)	N/A	N/A	DWS Offset (in)	N/A
N/A	Shared Landing?	N/A			
N/A	Gutter Ponding?	N/A	N/A	Gutter Slope (%)	N/A
N/A	Gutter Lip Ht (in)	N/A	N/A	Gutter X Slope (%)	N/A
N/A	Painted X Walk1?	No	N/A	Painted X Walk2?	No
	X Walk 1 Direction	To W		X Walk 2 Direction	To S
N/A	X Walk 1 Width (in)	N/A	N/A	X Walk 2 Width (in)	N/A
	X Walk 1 Slope (%)	2.4		X Walk 2 Slope (%)	1.4
	X Walk 1 X Slope (%)	1.9		X Walk 2 X Slope (%)	1.9

N/A	Ramp inside XWalk1?	N/A	N/A	Ramp inside XWalk2?	N/A
	Road Slope (%)	1.7	N/A	Clear Space?	N/A
	Road X Slope (%)	0.1	N/A	Clear Space to XWalk (in)	N/A
N/A	Any Obstructions?	N/A	N/A	Storm Grate/Utility Hazard?	N/A
	Obstruction Type			Storm Grate/Utility Type	
		N/A			N/A
			Yes	Surface Condition? (G/P)	Good

Remove & Replace Curb Ramp With Two New Directional Ramps or Equivalent.

R304.5.1, R304.5.3
