Access Compliance Report

Public Rights-of-Way

(Curb Ramps)

Intersection ID: 6670	Main Street: BELMAR_PLACE_RD	Cross Street: ERNIE_DR	Location: SE
ADA ID: BB852ADAFEBE	Ramp Type: PerpDiag	Initial Pass/Fail: Fail	Overall Compliance: No
Severity Score: 21.25			
Codes/Mitigation Info/Possible Solution		Field Measurements/Component Compliance

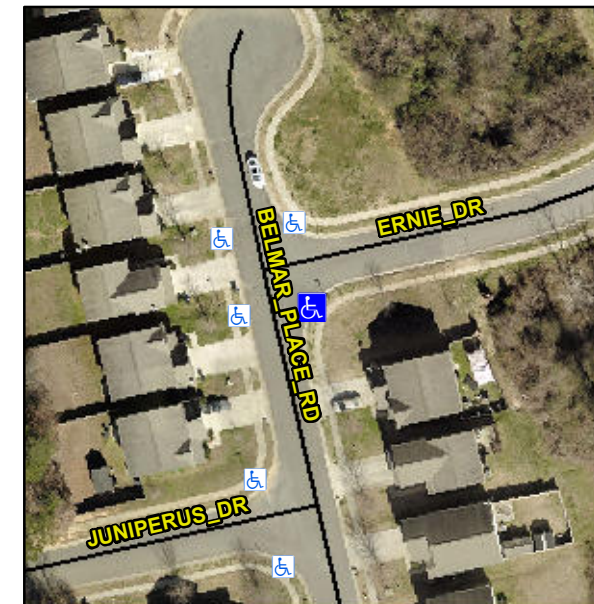
Compliance	Description	Data	Compliance	Description	Data
N/A	Ramp Length (in)	50.5	Yes	Ramp Slope (%)	5.2
No	Ramp Width (in)	46.0	No	Ramp XSlope (%)	6.8
N/A	Flare Type LT	N/A	N/A	Flare Type RT	N/A
N/A	Flare Slope LT (%)	N/A	N/A	Flare Slope RT (%)	N/A
N/A	Flare Traversable LT?	N/A	N/A	Flare Traversable RT?	N/A
N/A	Landing Length (in)	N/A	N/A	DWS Provided?	N/A
N/A	Landing Width (in)	N/A	N/A	DWS Contrast?	N/A
N/A	Landing Slope (%)	N/A	N/A	DWS Length (in)	N/A
N/A	Landing X Slope (%)	N/A	N/A	DWS Full Width?	N/A
N/A	Landing Curb? (Y/N)	N/A	N/A	DWS Offset (in)	N/A
N/A	Shared Landing?	N/A			
N/A	Gutter Ponding?	N/A	N/A	Gutter Slope (%)	N/A
N/A	Gutter Lip Ht (in)	N/A	N/A	Gutter X Slope (%)	N/A
N/A	Painted X Walk1?	No	N/A	Painted X Walk2?	No
	X Walk 1 Direction	To N		X Walk 2 Direction	To W
N/A	X Walk 1 Width (in)	N/A	N/A	X Walk 2 Width (in)	N/A
	X Walk 1 Slope (%)	4.2		X Walk 2 Slope (%)	5.5
	X Walk 1 X Slope (%)	6.0		X Walk 2 X Slope (%)	2.7

N/A	Ramp inside XWalk1?	N/A	N/A	Ramp inside XWalk2?	N/A
	Road Slope (%)	6.3	N/A	Clear Space?	N/A
	Road X Slope (%)	1.3	N/A	Clear Space to XWalk (in)	N/A
N/A	Any Obstructions?	N/A	N/A	Storm Grate/Utility Hazard?	N/A
	Obstruction Type			Storm Grate/Utility Type	
		N/A			N/A
			Yes	Surface Condition? (G/P)	Good

Possible Solutions:

Remove & Replace Curb Ramp With Two New Directional Ramps or Equivalent.

R304.5.1, R304.5.3
