Access Compliance Report

Public Rights-of-Way

(Curb Ramps)

Intersection ID: 10041704	Main Street: WILD_ELM_RD	Cross Street: N/A	Location:	N
ADA ID: BB8B5EFFB916	Ramp Type: Perp	Initial Pass/Fail: Fail	Overall Compliance: No	Severity Score: 13.75
Codes/Mitigation Info/Possible Solution		Field Measurements/Component Compliance

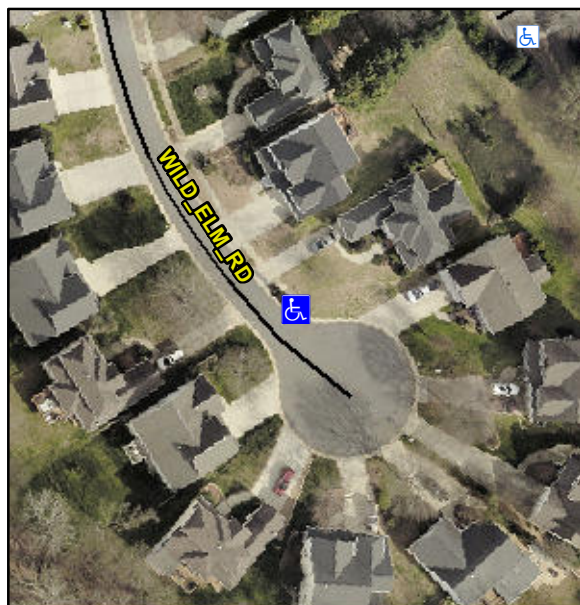
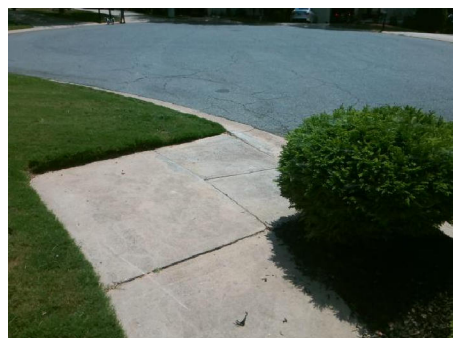
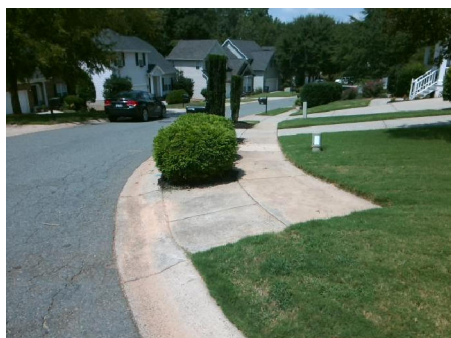
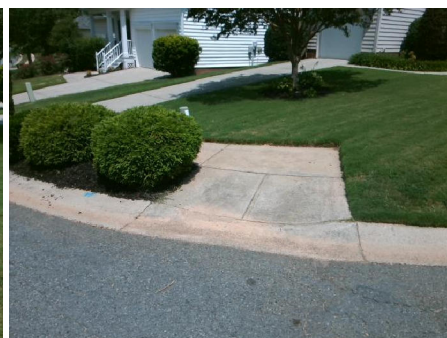
Compliance	Description	Data	Compliance	Description	Data
N/A	Ramp Length (in)	46.0	No	Ramp Slope (%)	10.2
Yes	Ramp Width (in)	48.0	Yes	Ramp XSlope (%)	4.0
N/A	Flare Type LT	N/A	N/A	Flare Type RT	N/A
N/A	Flare Slope LT (%)	N/A	N/A	Flare Slope RT (%)	N/A
N/A	Flare Traversable LT?	N/A	N/A	Flare Traversable RT?	N/A
N/A	Landing Length (in)	N/A	N/A	DWS Provided?	N/A
N/A	Landing Width (in)	N/A	N/A	DWS Contrast?	N/A
N/A	Landing Slope (%)	N/A	N/A	DWS Length (in)	N/A
N/A	Landing X Slope (%)	N/A	N/A	DWS Full Width?	N/A
N/A	Landing Curb? (Y/N)	N/A	N/A	DWS Offset (in)	N/A
N/A	Shared Landing?	N/A			
N/A	Gutter Ponding?	N/A	N/A	Gutter Slope (%)	N/A
N/A	Gutter Lip Ht (in)	N/A	N/A	Gutter X Slope (%)	N/A
N/A	Painted X Walk1?	No	N/A	Painted X Walk2?	N/A
	X Walk 1 Direction	To SW		X Walk 2 Direction	N/A
N/A	X Walk 1 Width (in)	N/A	N/A	X Walk 2 Width (in)	N/A
	X Walk 1 Slope (%)	4.5		X Walk 2 Slope (%)	N/A
	X Walk 1 X Slope (%)	6.1		X Walk 2 X Slope (%)	N/A

N/A	Ramp inside XWalk1?	N/A	N/A	Ramp inside XWalk2?	N/A
	Road Slope (%)	N/A	N/A	Clear Space?	N/A
	Road X Slope (%)	N/A	N/A	Clear Space to XWalk (in)	N/A
N/A	Any Obstructions?	N/A	N/A	Storm Grate/Utility Hazard?	N/A
	Obstruction Type			Storm Grate/Utility Type	
		N/A			N/A
			Yes	Surface Condition? (G/P)	Good

Possible Solutions:

Remove & Replace Entire Ramp.

R304.2.2
