# Access Compliance Report

## Public Rights-of-Way

| Intersection ID: 48058 | Main Street: FERRELL_AV | Cross Street: KEENER_RIDGE_RD | Location: NW |
| ADA ID: BB9A165033A1 | Ramp Type: Perp | Initial Pass/Fail: Pass | Overall Compliance: No |

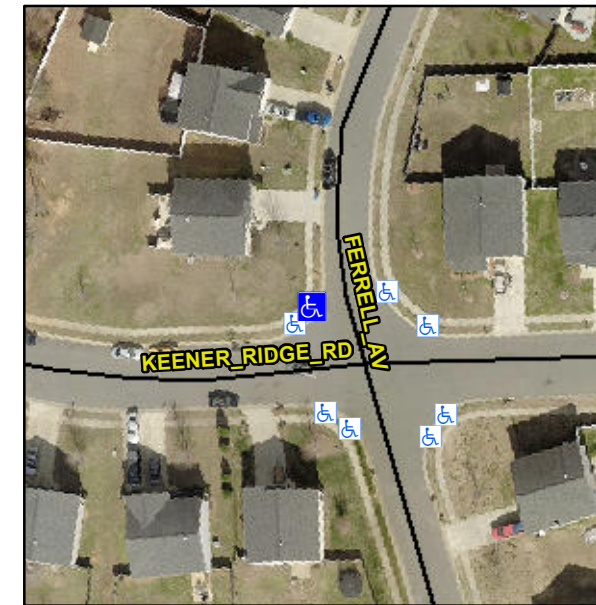
**Not Found, R304.5.3, R304.2.1,  
R304.2.2-Perp, R304.3.2-Para,  
R304.5.4**

| Compliance | Description | Data | Compliance | Description | Data |
|---|---|---|---|---|---|
| Yes | Ramp Width (in) | 48.0 | No | Ramp XSlope (%) | 4.0 |
| No | Landing Width (in) | 25.0 | Yes | DWS Contrast? | Yes |
| No | Landing Slope (%) | 2.8 | Yes | DWS Length (in) | 25.0 |
| No | Landing X Slope (%) | 5.7 | Yes | DWS Full Width? | Yes |
| Yes | Gutter Ponding? | No | No | Gutter Slope (%) | 9.7 |
| Yes | Gutter Lip Ht (in) | 0.0 | No | Gutter X Slope (%) | 3.7 |

**Remove & Replace Entire Ramp.  
Remove & Replace Gutter.**
