Access Compliance Report

Public Rights-of-Way

(Curb Ramps)

Intersection ID: 17274	Main Street: MONROE_RD	Cross Street: VISTA_DR	Location: NW
ADA ID: BBA1C4BE81BB	Ramp Type: Directional1	Initial Pass/Fail: Pass	Overall Compliance: Yes
		Severity Score: 0	
Codes/Mitigation Info/Possible Solution		Field Measurements/Component Compliance

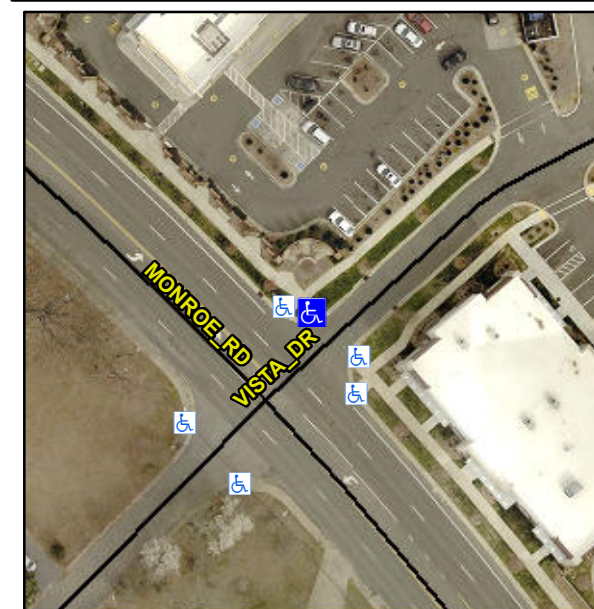
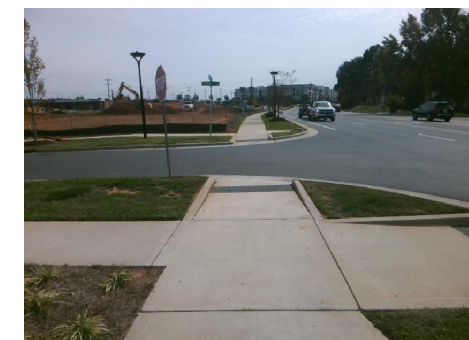
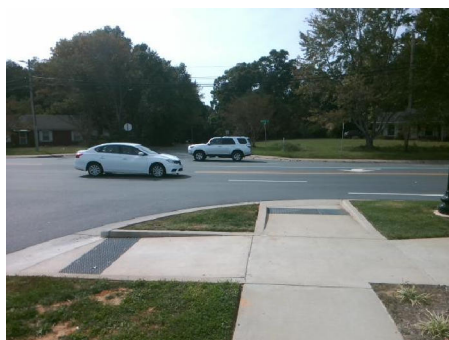
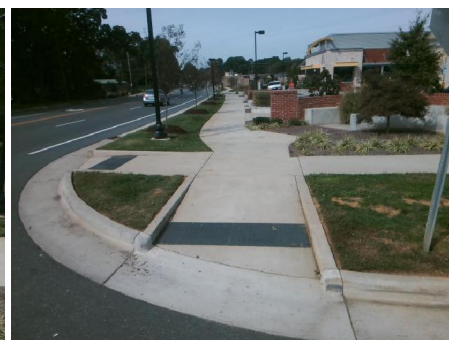
Compliance	Description	Data	Compliance	Description	Data
N/A	Ramp Length (in)	103.0	Yes	Grade Break?	Yes
Yes	Ramp Width (in)	70.0	Yes	Grade Break Slope (%)	1.2
Yes	Ramp Slope (%)	4.8	Yes	Grade Break XSlope (%)	1.3
Yes	Ramp XSlope (%)	0.6			
Yes	Flare Type LT	N/A	Yes	Flare Type RT	N/A
N/A	Flare Slope LT (%)	N/A	N/A	Flare Slope RT (%)	N/A
N/A	Flare Traversable LT?	No	N/A	Flare Traversable RT?	No
Yes	Landing Length (in)	91.0	Yes	DWS Provided?	Yes
Yes	Landing Width (in)	70.0	Yes	DWS Contrast?	Yes
Yes	Landing Slope (%)	0.8	Yes	DWS Length (in)	24.0
Yes	Landing X Slope (%)	0.1	Yes	DWS Full Width?	Yes
N/A	Landing Curb? (Y/N)	No	Yes	DWS Offset LT (in)	0.0
N/A	Shared Landing?	Yes	Yes	DWS Offset RT (in)	23.0
Yes	Gutter Ponding?	No	Yes	Gutter Slope (%)	1.4
Yes	Gutter Lip Ht (in)	0.0	Yes	Gutter X Slope (%)	1.1
N/A	Painted X Walk1?	No		Road Slope (%)	1.9
	X Walk 1 Direction	To SE		Road X Slope (%)	0.2
	X Walk 1 Width (in)	N/A		Clear Space?	Yes

X Walk 1 Slope (%)	1.9	N/A	Clear Space to XWalk (in)	N/A
	X Walk 1 X Slope (%)	0.2	Yes	Storm Grate/Utility Hazard?	No
N/A	Ramp inside XWalk1?	N/A		Storm Grate/Utility Type	
Yes	Any Obstructions?	No			N/A
	Obstruction Type		Yes	Surface Condition? (G/P)	Good
			N/A	Curb Slope (%)	2.4
