# Access Compliance Report

## Public Rights-of-Way

### (Curb Ramps)

| Intersection ID: 45497 | Main Street: ELIZABETH_CREST_LN | Cross Street: COTTON_PRESS_RD | Location: SE |

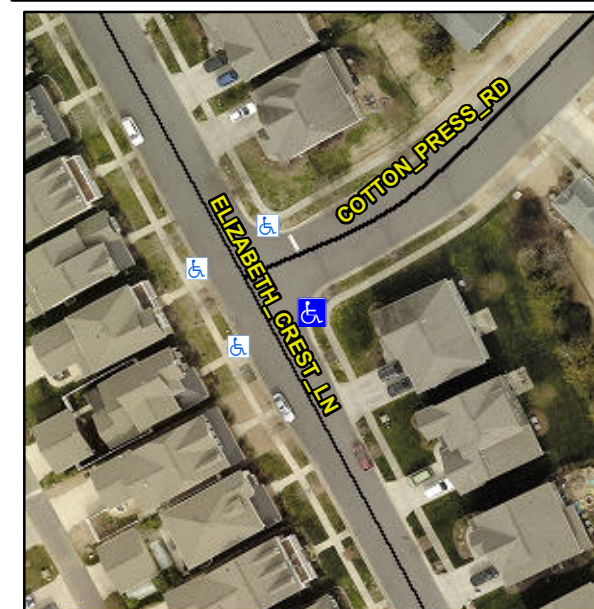
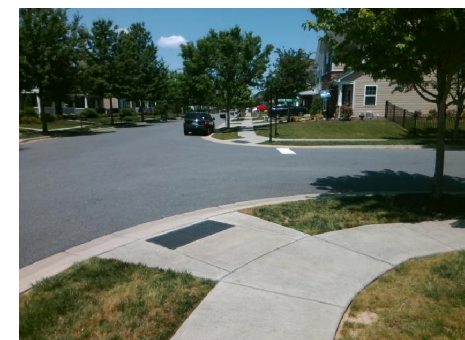
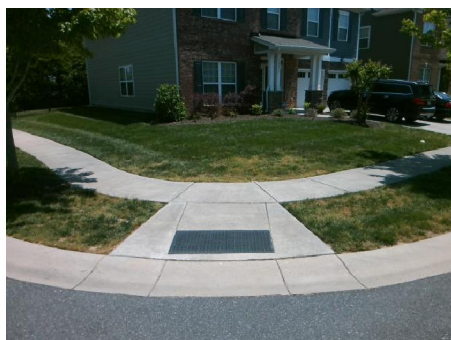
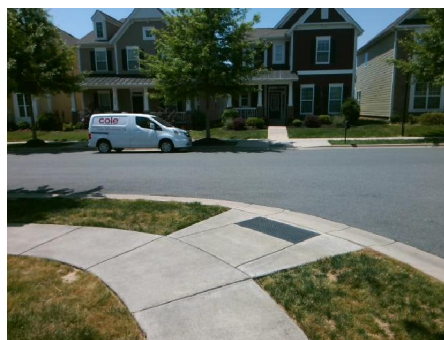
| ADA ID: BBA25F7352C2 | Ramp Type: BlendTrans1 | Initial Pass/Fail: Pass | Overall Compliance: No |

**Not Found, R304.2.1, R304.2.2-Perp, R304.3.2-Para, R305.2, R304.5.4**

| Compliance | Description | Data | Compliance | Description | Data |
|---|---|---|---|---|---|
| No | Landing Width (in) | 46.0 | Yes | DWS Contrast? | Yes |
| No | Landing Slope (%) | 2.4 | Yes | DWS Length (in) | 24.5 |
| N/A | Landing Curb? (Y/N) | No | No | DWS Offset (in) | 5.0 |
| Yes | Gutter Ponding? | No | No | Gutter Slope (%) | 15.6 |
| | | | No | Curb Slope (%) | 10.8 |

**Remove & Replace Curb Ramp With Two New Directional Ramps or Equivalent. Remove & Replace Gutter.**
