Access Compliance Report

Public Rights-of-Way

(Curb Ramps)

Intersection ID: 20587	Main Street: COLONY_RD	Cross Street: FAIRVIEW_RD	Location: SE
ADA ID: BBA27A130CC6	Ramp Type: Para	Initial Pass/Fail: Fail	Overall Compliance: No
Severity Score: 13.75			
Codes/Mitigation Info/Possible Solution		Field Measurements/Component Compliance

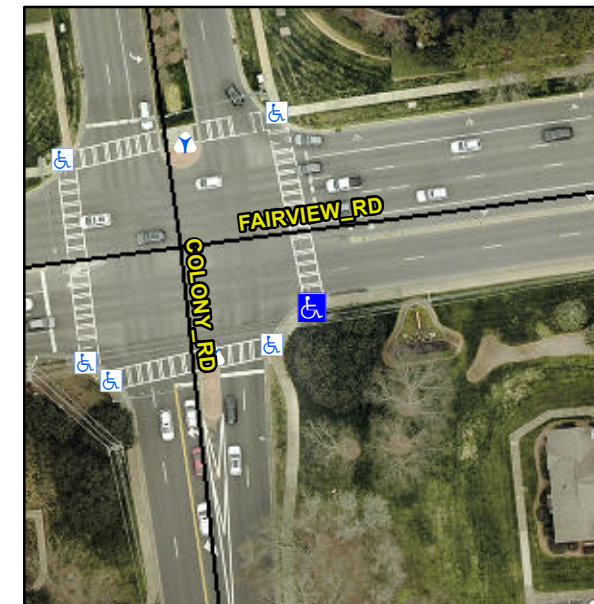
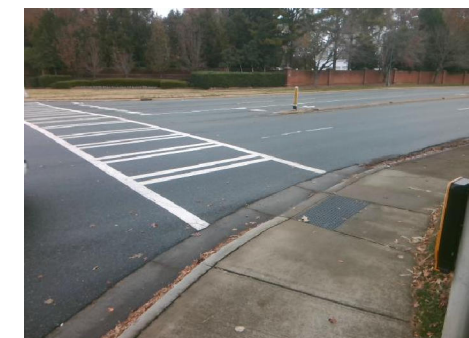
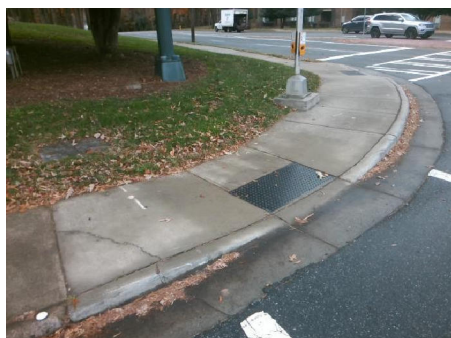
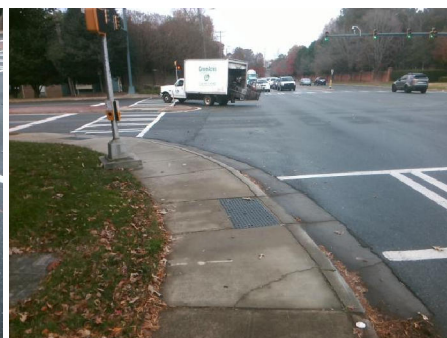
Compliance	Description	Data	Compliance	Description	Data
N/A	Ramp Length LT (in)	64.0	N/A	Ramp Length RT (in)	52.0
Yes	Ramp Width LT (in)	60.0	Yes	Ramp Width RT (in)	70.0
No	Ramp Slope LT (%)	8.7	Yes	Ramp Slope RT (%)	7.6
No	Ramp XSlope LT (%)	2.2	Yes	Ramp XSlope RT (%)	1.1
N/A	Landing Length (in)	N/A	N/A	DWS Provided?	N/A
N/A	Landing Width (in)	N/A	N/A	DWS Contrast?	N/A
N/A	Landing Slope (%)	N/A	N/A	DWS Length (in)	N/A
N/A	Landing X Slope (%)	N/A	N/A	DWS Full Width?	N/A
N/A	Landing Curb? (Y/N)	N/A	N/A	DWS Offset (in)	N/A
N/A	Shared Landing?	N/A			
N/A	Gutter Ponding?	N/A	N/A	Gutter Slope (%)	N/A
N/A	Gutter Lip Ht (in)	N/A	N/A	Gutter X Slope (%)	N/A
N/A	Painted X Walk1?	Yes	N/A	Painted X Walk2?	N/A
	X Walk 1 Direction	To N		X Walk 2 Direction	N/A
N/A	X Walk 1 Width (in)	116.0	N/A	X Walk 2 Width (in)	N/A
	X Walk 1 Slope (%)	3.3		X Walk 2 Slope (%)	N/A
	X Walk 1 X Slope (%)	1.4		X Walk 2 X Slope (%)	N/A
N/A	Ramp inside XWalk1?	Yes	N/A	Ramp inside XWalk2?	N/A

Road Slope (%)	N/A	N/A	Clear Space?	N/A
	Road X Slope (%)	N/A	N/A	Clear Space to XWalk (in)	N/A
N/A	Any Obstructions?	N/A	N/A	Storm Grate/Utility Hazard?	N/A
	Obstruction Type			Storm Grate/Utility Type	
		N/A			N/A
			Yes	Surface Condition? (G/P)	Good
			N/A	Curb Slope (%)	0.5

Remove & Replace Entire Ramp.

R304.3.2, R304.5.3
