Access Compliance Report

Public Rights-of-Way

(Curb Ramps)

Intersection ID: 24621	Main Street: HUGH_FOREST_RD	Cross Street: WALTHAM_LN	Location: SE
ADA ID: BBA88AC015A6	Ramp Type: PerpDiag	Initial Pass/Fail: Fail	Overall Compliance: No
Severity Score: 10			
Codes/Mitigation Info/Possible Solution		Field Measurements/Component Compliance

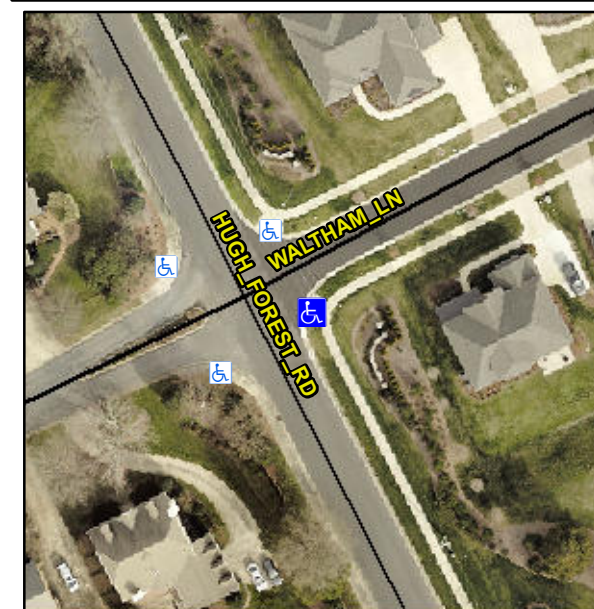
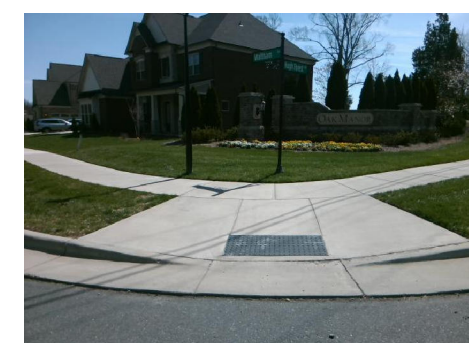
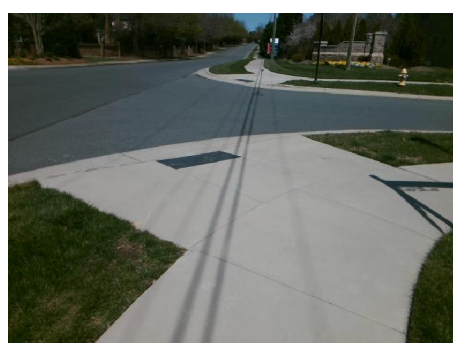
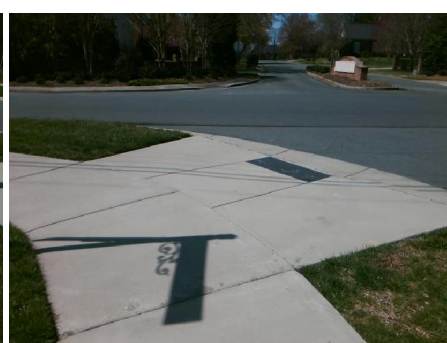
Not Found, R304.5.1, R304.5.3

Compliance	Description	Data	Compliance	Description	Data
N/A	Ramp Length (in)	95.0	Yes	Ramp Slope (%)	7.7
No	Ramp Width (in)	47.0	No	Ramp XSlope (%)	2.7
N/A	Flare Type LT	N/A	N/A	Flare Type RT	N/A
N/A	Flare Slope LT (%)	N/A	N/A	Flare Slope RT (%)	N/A
N/A	Flare Traversable LT?	N/A	N/A	Flare Traversable RT?	N/A
N/A	Landing Length (in)	N/A	N/A	DWS Provided?	N/A
N/A	Landing Width (in)	N/A	N/A	DWS Contrast?	N/A
N/A	Landing Slope (%)	N/A	N/A	DWS Length (in)	N/A
N/A	Landing X Slope (%)	N/A	N/A	DWS Full Width?	N/A
N/A	Landing Curb? (Y/N)	N/A	N/A	DWS Offset (in)	N/A
N/A	Shared Landing?	N/A			
N/A	Gutter Ponding?	N/A	N/A	Gutter Slope (%)	N/A
N/A	Gutter Lip Ht (in)	N/A	N/A	Gutter X Slope (%)	N/A
N/A	Painted X Walk1?	No	N/A	Painted X Walk2?	No
	X Walk 1 Direction	To N		X Walk 2 Direction	To W
N/A	X Walk 1 Width (in)	N/A	N/A	X Walk 2 Width (in)	N/A
	X Walk 1 Slope (%)	1.3		X Walk 2 Slope (%)	4.9
	X Walk 1 X Slope (%)	2.1		X Walk 2 X Slope (%)	0.7

N/A	Ramp inside XWalk1?	N/A	N/A	Ramp inside XWalk2?	N/A
	Road Slope (%)	2.8	N/A	Clear Space?	N/A
	Road X Slope (%)	3.1	N/A	Clear Space to XWalk (in)	N/A
N/A	Any Obstructions?	N/A	N/A	Storm Grate/Utility Hazard?	N/A
	Obstruction Type			Storm Grate/Utility Type	
		N/A			N/A
			Yes	Surface Condition? (G/P)	Good

Remove & Replace Curb Ramp With Two New Directional Ramps or Equivalent.
