## **Access Compliance Report Public Rights-of-Way** (Curb Ramps)

Intersection ID: 31895 Main Street: SLALOM HILL RD Cross Street: STOWE DERBY DR Location: **ADA ID: BBA88D3C2518** Ramp Type: PerpDiag Initial Pass/Fail: Fail **Overall Compliance: No Severity Score:** 10

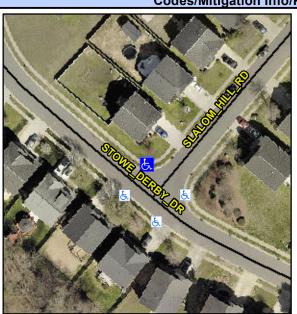
Field Measurements/Component Compliance								
	Compli	ance Description		Data	Compliance		Description	Data
	N/A	Ramp	Length (in)	47.0	Yes	Ramp	Slope (%)	6.7
	No	Ramp	Width (in)	41.0	No	Ramp	XSlope (%)	3.5
	N/A	Flare	Type LT	N/A	N/A	Flare	Type RT	N/A
	N/A	Flare	Slope LT (%)	N/A	N/A	Flare	Slope RT (%)	N/A
	N/A	Flare	Traversable LT?	N/A	N/A	Flare	Traversable RT?	N/A
	N/A	Landii	ng Length (in)	N/A	N/A	DWS	Provided?	N/A
	N/A	Landii	ng Width (in)	N/A	N/A	DWS	Contrast?	N/A
	N/A	Landii	ng Slope (%)	N/A	N/A	DWS	Length (in)	N/A
	N/A	Landii	ng X Slope (%)	N/A	N/A	DWS	Full Width?	N/A
	N/A	Landii	ng Curb? (Y/N)	N/A	N/A	DWS	Offset (in)	N/A
	N/A	Share	d Landing?	N/A				
	N/A	Gutte	r Ponding?	N/A	N/A	Gutte	Slope (%)	N/A
	N/A	Gutte	r Lip Ht (in)	N/A	N/A	Gutte	X Slope (%)	N/A
	N/A	Painte	ed X Walk1?	No	N/A	Painte	ed X Walk2?	No
		X Wal	k 1 Direction	To SW		X Wal	k 2 Direction	To SE
	N/A	X Wal	k 1 Width (in)	N/A	N/A	X Wal	k 2 Width (in)	N/A

X Wal	k 1 Slope (%)	2.8		X Wal	k 2 Slope (%)	2.3
		X Wal	k 1 X Slope (%)	1.4		X Wal	k 2 X Slope (%)	2.4
	N/A	Ramp	inside XWalk1?	N/A	N/A	Ramp	inside XWalk2?	N/A
		Road	Slope (%)	2.2	N/A	Clear	Space?	N/A
		Road	X Slope (%)	4.6	N/A	Clear	Space to XWalk (in)	N/A
	N/A	Any C	bstructions?	N/A	N/A	Storm	Grate/Utility Hazard?	N/A
		Obstr	uction Type			Storm	Grate/Utility Type	
				N/A				N/A
					Yes	Surfac	ce Condition? (G/P)	Good
	1000	ANA	- K

Possible Solutions: Remove & Replace Curb Ramp With **Two New Directional Ramps or** Equivalent. Surveyor Notes: N/A PROW/ADA: R304.5.1, R304.5.3
