# Access Compliance Report

## Public Rights-of-Way

### (Curb Ramps)

| Intersection ID: 52453 | Main Street: PAT_GARRETT_ST | Cross Street: DOUBLE_OAKS_RD | Location: SE |

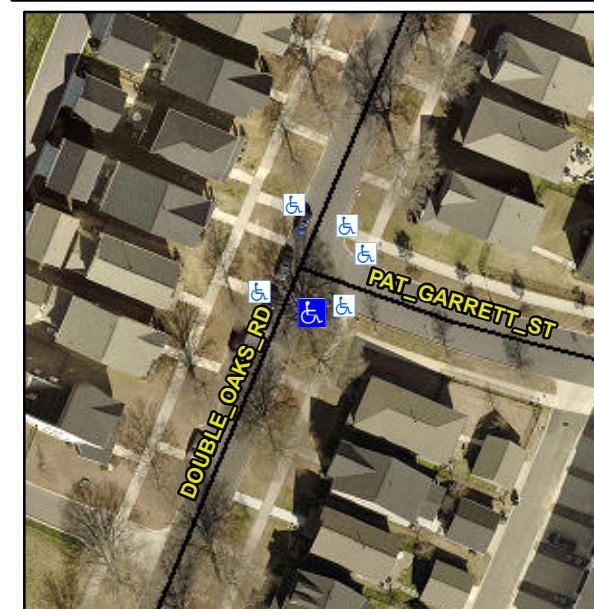
**R304.5.3, R302.7.2, R304.5.4**

| Compliance | Description | Data | Compliance | Description | Data |
|---|---|---|---|---|---|
| N/A | Ramp Length (in) | 80.0 | Yes | Grade Break? | Yes |
| Yes | Ramp Width (in) | 66.0 | No | Grade Break Slope (%) | 6.0 |
| Yes | Ramp Slope (%) | 6.2 | No | Grade Break XSlope (%) | 2.8 |
| No | Ramp XSlope (%) | 3.2 | | | |
| No | Landing X Slope (%) | 3.6 | Yes | DWS Full Width? | Yes |
| Yes | Gutter Ponding? | No | No | Gutter Slope (%) | 6.5 |
| No | Gutter Lip Ht (in) | 1.0 | No | Gutter X Slope (%) | 3.5 |

Possible Solutions:

**Remove & Replace Entire Ramp.  
Remove & Replace Gutter.**

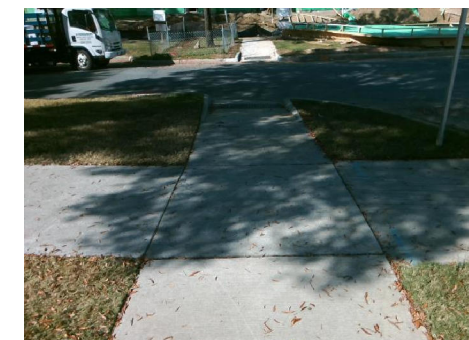
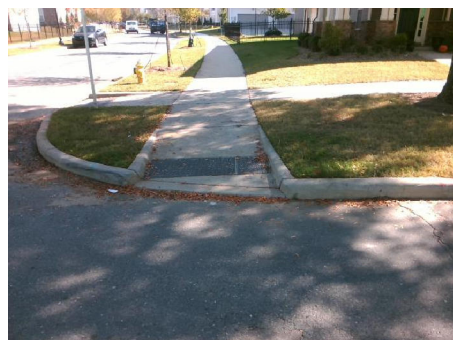
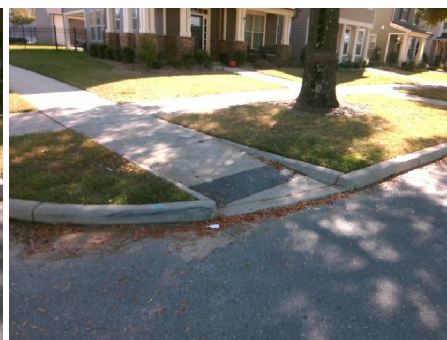
| ADA ID: BBADA46923DC | Ramp Type: Directional1 | Initial Pass/Fail: Pass | Overall Compliance: No |
| Severity Score: 20.25 | | | |

Total Cost: \$ 2350.00
