# Access Compliance Report

## Public Rights-of-Way

| Intersection ID: 10570 | Main Street: HERRIN_AV | Cross Street: HOLT_ST | Location: SE |
| ADA ID: BBB004767818 | Ramp Type: Perp | Initial Pass/Fail: Pass | Overall Compliance: No |

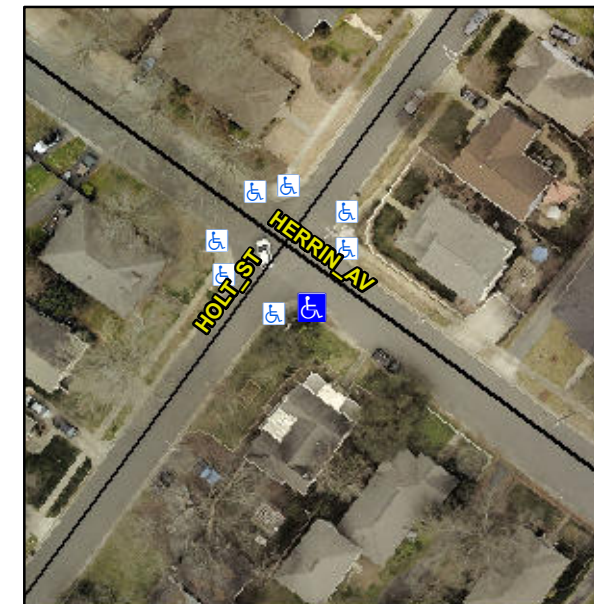
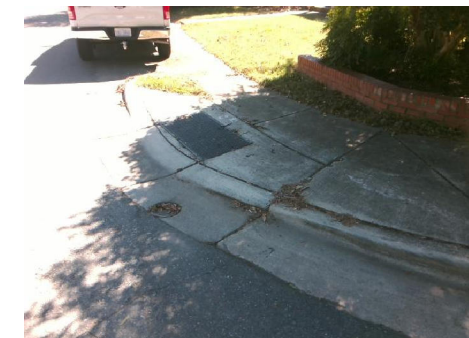
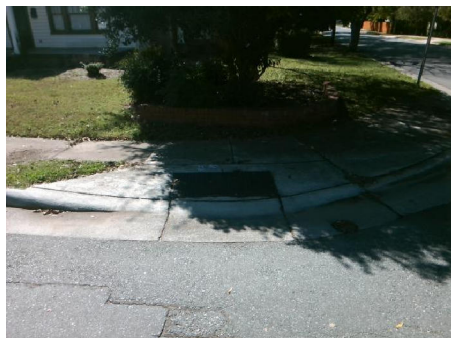
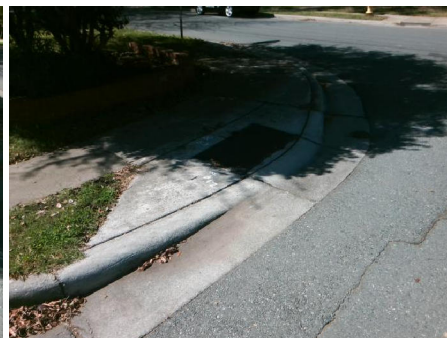
**Not Found, R304.5.3, R304.2.1,  
R304.2.2-Perp, R304.3.2-Para,  
R305.2**

| Compliance | Description | Data | Compliance | Description | Data |
|---|---|---|---|---|---|
| Yes | Ramp Width (in) | 48.0 | No | Ramp XSlope (%) | 3.0 |
| No | Landing Length (in) | 43.0 | Yes | DWS Provided? | Yes |
| No | Landing Slope (%) | 2.5 | Yes | DWS Length (in) | 24.5 |
| No | Landing X Slope (%) | 2.8 | Yes | DWS Full Width? | Yes |
| N/A | Landing Curb? (Y/N) | No | No | DWS Offset (in) | 3.5 |
| Yes | Gutter Lip Ht (in) | 0.0 | No | Gutter X Slope (%) | 3.2 |

**Remove & Replace Entire Ramp.  
Remove & Replace Gutter.**
