Access Compliance Report Public Rights-of-Way (Curb Ramps)

Intersection ID: 27355 Main Street: JOHNSTON_RD Cross Street: BRIXHAM_HILL_AV Location: SE **ADA ID: BBD1AFFD49D0** Ramp Type: Para Initial Pass/Fail: Fail **Overall Compliance: No** Severity Score: 21.25

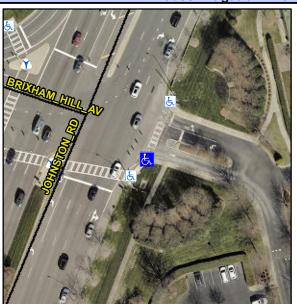
Field Measurements/Component Compliance					
Compliance Description		Data	Comp	liance Description	Data
N/A	Ramp Length LT (in)	46.0	N/A	Ramp Length RT (in)	54.0
No	Ramp Width LT (in)	46.0	Yes	Ramp Width RT (in)	60.0
No	Ramp Slope LT (%)	9.0	Yes	Ramp Slope RT (%)	7.4
Yes	Ramp XSlope LT (%)	0.3	Yes	Ramp XSlope RT (%)	0.5
N/A	Landing Length (in)	N/A	N/A	DWS Provided?	N/A
N/A	Landing Width (in)	N/A	N/A	DWS Contrast?	N/A
N/A	Landing Slope (%)	N/A	N/A	DWS Length (in)	N/A
N/A	Landing X Slope (%)	N/A	N/A	DWS Full Width?	N/A
N/A	Landing Curb? (Y/N)	N/A	N/A	DWS Offset (in)	N/A
N/A	Shared Landing?	N/A			
N/A	Gutter Ponding?	N/A	N/A	Gutter Slope (%)	N/A
N/A	Gutter Lip Ht (in)	N/A	N/A	Gutter X Slope (%)	N/A
N/A	Painted X Walk1?	Yes	N/A	Painted X Walk2?	N/A
	X Walk 1 Direction	To NE		X Walk 2 Direction	N/A
N/A	X Walk 1 Width (in)	73.0	N/A	X Walk 2 Width (in)	N/A
	X Walk 1 Slope (%)	2.4		X Walk 2 Slope (%)	N/A
	X Walk 1 X Slope (%)	0.7		X Walk 2 X Slope (%)	N/A

N/A	Ramp inside XWalk1?	Yes	N/A	Ramp inside XWalk2?	N/A
	Road Slope (%)	N/A	N/A	Clear Space?	N/A
	Road X Slope (%)	N/A	N/A	Clear Space to XWalk (in)	N/A
N/A	Any Obstructions?	N/A	N/A	Storm Grate/Utility Hazard?	N/A
	Obstruction Type			Storm Grate/Utility Type	
		N/A			N/A
			Yes	Surface Condition? (G/P)	Good
			N/A	Curb Slope (%)	22.0
1	The -

BRIXHAM MILL AV Street 1 Name Stop Condition-Street 1 Signal Street 2 Name N/A Stop Condition-Street 2 N/A Possible Solutions: Remove & Replace Entire Ramp. Surveyor Notes: N/A PROW/ADA: R304.5.1, R304.3.2
