# Access Compliance Report

## Public Rights-of-Way

### (Curb Ramps)

| Intersection ID: 49150 | Main Street: VIDAL_LN | Cross Street: DACAVIN_DR | Location: N |

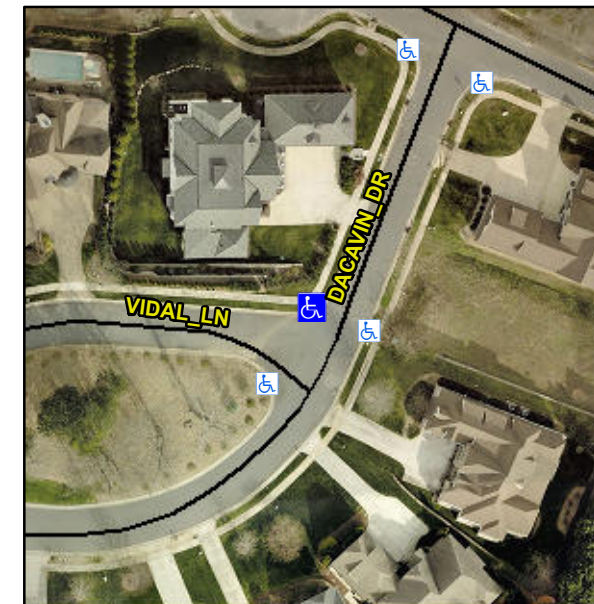
| ADA ID: BBE6B3B085FC | Ramp Type: BlendTrans2 | Initial Pass/Fail: Fail | Overall Compliance: No |
| | | Severity Score: 33.75 | |

**Not Found, R304.5.1, R304.5.3**

| Compliance | Description | Data | Compliance | Description | Data |
|---|---|---|---|---|---|
| No | Ramp Width (in) | 44.0 | No | BlendTrans XSlope (%) | 14.9 |

**Remove & Replace Curb Ramp With Two New Directional Ramps or Equivalent.**

Total Cost: \$ 3200.00
