Access Compliance Report

Public Rights-of-Way

(Curb Ramps)

| Intersection ID: 15382 | Main Street: FANNIE_CR | Cross Street: ORANGE_ST | Location: W |

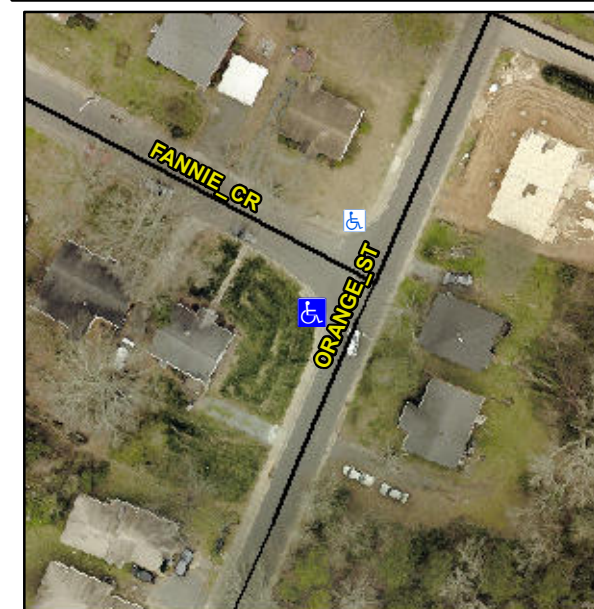
| ADA ID: BBEB68403640 | Ramp Type: PerpDiag | Initial Pass/Fail: Fail | Overall Compliance: No |
| Severity Score: 33.75 | | | |

Not Found, R304.5.1, R304.2.2

| Compliance | Description | Data | Compliance | Description | Data |
|---|---|---|---|---|---|
| N/A | Ramp Length (in) | 48.0 | No | Ramp Slope (%) | 12.6 |
| No | Ramp Width (in) | 41.0 | Yes | Ramp XSlope (%) | 0.6 |

Remove & Replace Curb Ramp With Two New Directional Ramps or Equivalent.

Total Cost: \$ 3200.00
