Access Compliance Report Public Rights-of-Way (Curb Ramps)

Intersection ID: 47976	Main Street: AVALY_LN			Street:	ARDREY_KELL_RD	Location:	NW		
ADA ID: BBEBEB1A5D93	5D93 Ramp Type: PerpDiag		Initial F	Initial Pass/Fail: Fail Overall Compliance: No				o Severity Score:	21.25
Codes/Mitigation Info/Possible Solution				Field Measurements/Component Compliance					
		Possible Solutions:		Compliance Description Data Complian			liance Description	Data	
		Remove & Replace Curb Ramp	With	N/A	Ramp Length (in)	88.0	No	Ramp Slope (%)	10.8
		Two New Directional Ramps or		No	Ramp Width (in)	46.5	Yes	Ramp XSlope (%)	0.9
		Equivalent.		N/A	Flare Type LT	N/A	N/A	Flare Type RT	N/A
				N/A	Flare Slope LT (%)	N/A	N/A	Flare Slope RT (%)	N/A
				N/A	Flare Traversable LT?	N/A	N/A	Flare Traversable RT?	N/A
				N/A	Landing Length (in)	N/A	N/A	DWS Provided?	N/A
A CONTRACTOR		Surveyor Notes:		N/A	Landing Width (in)	N/A	N/A	DWS Contrast?	N/A
		N/A		N/A	Landing Slope (%)	N/A	N/A	DWS Length (in)	N/A

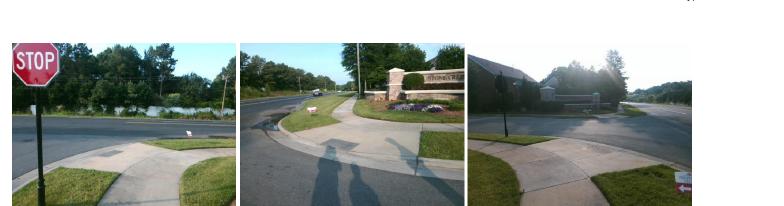
All and a second				N/A	Landing X Slope (%)	N/A	N/A	DWS Full Width?	N/A
EN m	L RD			N/A	Landing Curb? (Y/N)	N/A	N/A	DWS Offset (in)	N/A
ARDREN	Constant of			N/A	Shared Landing?	N/A			
		PROW/ADA:		N/A	Gutter Ponding?	N/A	N/A	Gutter Slope (%)	N/A
	Not Found, R304.5.1, R304.2.2		N/A	Gutter Lip Ht (in)	N/A	N/A	Gutter X Slope (%)	N/A	
The second s				N/A	Painted X Walk1?	No	N/A	Painted X Walk2?	No
CONTRACTOR OF					X Walk 1 Direction	To S		X Walk 2 Direction	To E
				N/A	X Walk 1 Width (in)	N/A	N/A	X Walk 2 Width (in)	N/A
Street 1 Name	ARDREY KELL RD				X Walk 1 Slope (%)	0.2		X Walk 2 Slope (%)	0.8
Stop Condition-Street 2	None				X Walk 1 X Slope (%)	1.2		X Walk 2 X Slope (%)	1.2
Street 2 Name	AVALY LN			N/A	Ramp inside XWalk1?	N/A	N/A	Ramp inside XWalk2?	N/A
Stop Condition-Street 1	StopSign				Road Slope (%)	1.4	N/A	Clear Space?	N/A
					Road X Slope (%)	0.3	N/A	Clear Space to XWalk (in)	N/A
				N/A	Any Obstructions?	N/A	N/A	Storm Grate/Utility Hazard?	N/A

Yes Surface Condition? (G/P)

Good

Total Cost: \$	3200.00		Obstruction Type			Storm Grate/Utility Type	
						N/A			N/A
4							I
