# Access Compliance Report

## Public Rights-of-Way

### (Curb Ramps)

| Intersection ID: 27788 | Main Street: PROVIDENCE_RD | Cross Street: PROVIDENCE_COUNTRY_CLUB_DR | Location: NW |

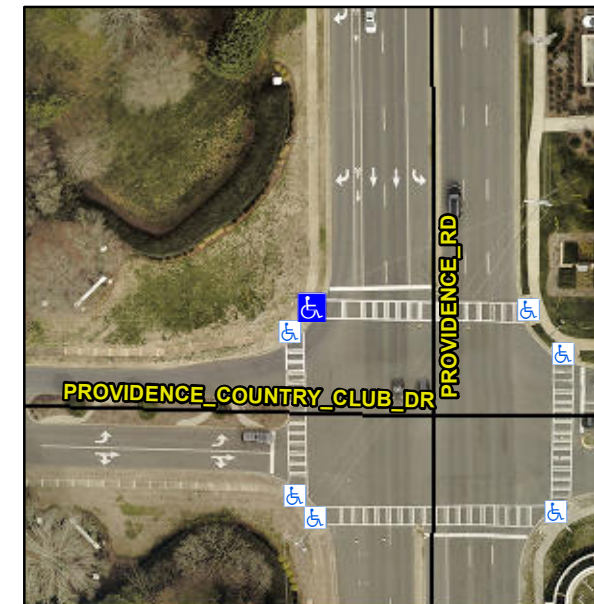
| ADA ID: BBF2F6BB5E27 | Ramp Type: BlendTrans1 | Initial Pass/Fail: Pass | Overall Compliance: No |
| | | Severity Score: 0.25 | |

**R304.5.3, R304.2.2-Perp, R304.3.2-Para, R305.2**

| Compliance | Description | Data | Compliance | Description | Data |
|---|---|---|---|---|---|
| Yes | Ramp Width (in) | 58.0 | No | BlendTrans XSlope (%) | 4.3 |
| No | Landing Slope (%) | 3.0 | Yes | DWS Length (in) | 25.0 |
| No | Landing X Slope (%) | 5.1 | Yes | DWS Full Width? | Yes |
| N/A | Landing Curb? (Y/N) | No | No | DWS Offset (in) | 4.0 |
| Yes | Gutter Lip Ht (in) | 0.0 | No | Gutter X Slope (%) | 4.0 |

**Remove & Replace Curb Ramp With Two New Directional Ramps or Equivalent. Remove & Replace Gutter.**

Total Cost: \$ 3950.00
