# Access Compliance Report

## Public Rights-of-Way

### (Curb Ramps)

| Intersection ID: N/A | Main Street: CANTERBURY_CASTLE_DR | Cross Street: SPRINGWOOD_ESTATE_DR | Location: SW |

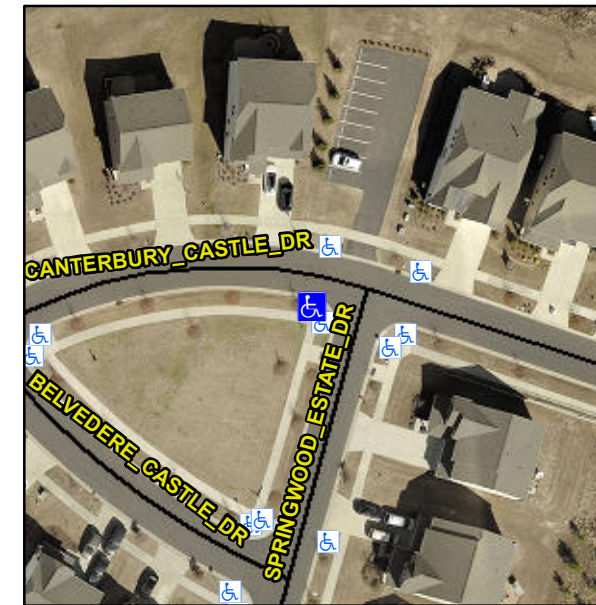
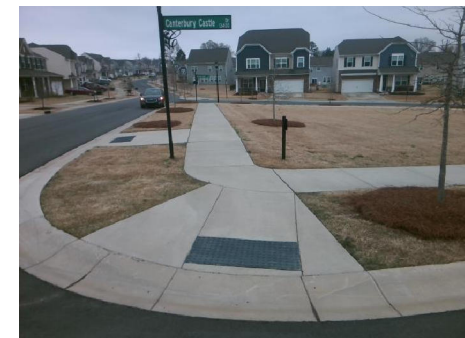
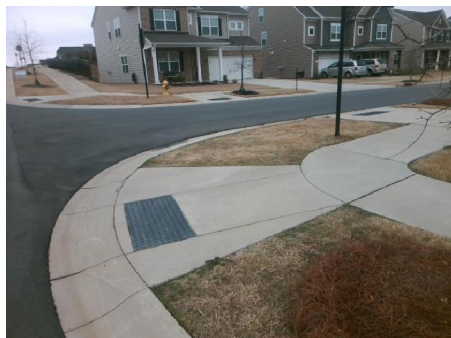
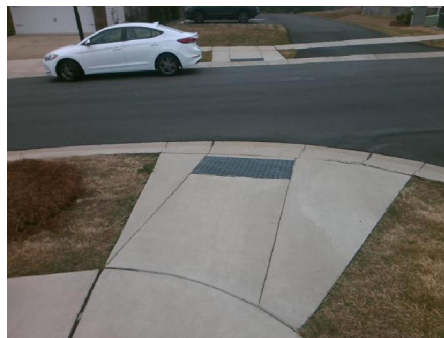
| ADA ID: BBF7AA30C1FB | Ramp Type: BlendTrans1 | Initial Pass/Fail: Fail | Overall Compliance: No |
| Severity Score: 21.25 | | | |

**Not Found, R304.5.1, R304.5.3**

| Compliance | Description | Data | Compliance | Description | Data |
|---|---|---|---|---|---|
| No | Ramp Width (in) | 47.0 | No | BlendTrans XSlope (%) | 6.3 |

**Remove & Replace Curb Ramp With Two New Directional Ramps or Equivalent.**

Total Cost: \$ 3200.00
