Access Compliance Report Public Rights-of-Way (Curb Ramps)

Intersection ID: 5704 Main Street: W_W_T_HARRIS_BV Cross Street: N_TRYON_ST Location: N

ADA ID: BBF9670F5763 Ramp Type: Directional1 Initial Pass/Fail: Fail Overall Compliance: No Severity Score: 12.5

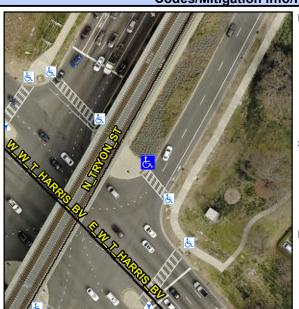
Field Measurements/Component Compliance							
Compl	iance Description	Data	Comp	liance Description	Data		
N/A	Ramp Length (in)	108.0	N/A	Grade Break?	N/A		
Yes	Ramp Width (in)	120.0	N/A	Grade Break Slope (%)	0.0		
No	Ramp Slope (%)	11.5	N/A	Grade Break XSlope (%)	0.0		
Yes	Ramp XSlope (%)	0.2					
N/A	Flare Type LT	N/A	N/A	Flare Type RT	N/A		
N/A	Flare Slope LT (%)	N/A	N/A	Flare Slope RT (%)	0.0		
N/A	Flare Traversable LT?	N/A	N/A	Flare Traversable RT?	N/A		
N/A	Landing Length (in)	0.0	N/A	DWS Provided?	N/A		
N/A	Landing Width (in)	0.0	N/A	DWS Contrast?	N/A		
N/A	Landing Slope (%)	0.0	N/A	DWS Length (in)	N/A		
N/A	Landing X Slope (%)	0.0	N/A	DWS Full Width?	N/A		
N/A	Landing Curb? (Y/N)	N/A	N/A	DWS Offset LT (in)	N/A		
N/A	Shared Landing?	N/A	N/A	DWS Offset RT (in)	N/A		
N/A	Gutter Ponding?	0.0	N/A	Gutter Slope (%)	N/A		
N/A	Gutter Lip Ht (in)	1.0	N/A	Gutter X Slope (%)	N/A		
N/A	Painted X Walk1?	No		Road Slope (%)	0.0

X Walk 1 Direction	To SE		Road X Slope (%)	0.9		
	X Walk 1 Width (in)	N/A		Clear Space?	N/A		
	X Walk 1 Slope (%)	0.0	N/A	Clear Space to XWalk (in)	N/A		
	X Walk 1 X Slope (%)	0.9	N/A	Storm Grate/Utility Hazard?	N/A		
N/A	Ramp inside XWalk1?	N/A		Storm Grate/Utility Type			
N/A	Any Obstructions?	N/A			N/A		
	Obstruction Type		Yes	Surface Condition? (G/P)	Good		
		N/A	N/A	Curb Slope (%)	N/A

Possible Solutions:					
Remove & Replace Entire Ramp.					
Surveyor Notes:					
LOCATED ON MEDIAN					
PROW/ADA:					
R304.2.2

Total Cost:	\$ 1600.00
