Access Compliance Report

Public Rights-of-Way

(Curb Ramps)

Intersection ID: 50320		Main Street: BRYN_ATHYN_CT		Cross Street: CINDY_LN		Location: NE											
ADA ID: BBFED8EB787B		Ramp Type: Directional1		Initial Pass/Fail: Pass		Overall Compliance: No		Severity Score: 2.75									
Codes/Mitigation Info/Possible Solution				Field Measurements/Component Compliance													
<div>

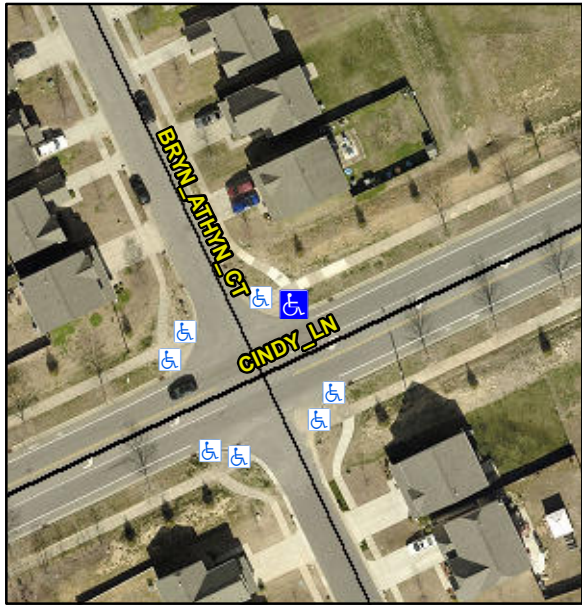
Yes		Ramp Slope (%)		8.1		Yes		Grade Break XSlope (%)		1.9			
				Yes		Ramp XSlope (%)		2.7									
				Yes		Flare Type LT		N/A		Yes		Flare Type RT		N/A			
				N/A		Flare Slope LT (%)		N/A		N/A		Flare Slope RT (%)		N/A			
				N/A		Flare Traversable LT?		No		N/A		Flare Traversable RT?		No			
				Yes		Landing Length (in)		73.5		Yes		DWS Provided?		Yes			
				Yes		Landing Width (in)		79.5		Yes		DWS Contrast?		Yes			
				Yes		Landing Slope (%)		1.2		Yes		DWS Length (in)		24.0			
				No		Landing X Slope (%)		3.0		No		DWS Full Width?		No			
				N/A		Landing Curb? (Y/N)		N/A		No		DWS Offset LT (in)		9.5			
				N/A		Shared Landing?		Yes		Yes		DWS Offset RT (in)		15.5			
				Yes		Gutter Ponding?		No		Yes		Gutter Slope (%)		3.3			
				Yes		Gutter Lip Ht (in)		0.0		Yes		Gutter X Slope (%)		0.4			
				N/A		Painted X Walk1?		No				Road Slope (%)		4.5			
						X Walk 1 Direction		To S				Road X Slope (%)		2.7

X Walk 1 Width (in)		N/A				Clear Space?		Yes			
						X Walk 1 Slope (%)		4.5		N/A		Clear Space to XWalk (in)		N/A			
						X Walk 1 X Slope (%)		2.7		Yes		Storm Grate/Utility Hazard?		No			
				N/A		Ramp inside XWalk1?		N/A				Storm Grate/Utility Type					
				Yes		Any Obstructions?		No						N/A			
						Obstruction Type				Yes		Surface Condition? (G/P)		Good			
										N/A		N/A		Curb Slope (%)		N/A

</div> <div>Possible Solutions:</div> <div>Remove & Replace Entire Ramp.</div> <div>Surveyor Notes:</div> <div>N/A</div> <div>PROW/ADA:</div> <div>R304.5.3, R305.1.4, R305.2</div> <div>Street 1 Name</div> <div>CINDY LN</div> <div>Stop Condition-Street 1</div> <div>None</div> <div>Street 2 Name</div> <div>N/A</div> <div>Stop Condition-Street 2</div> <div>N/A</div> <div>Total Cost:</div> <div>\$</div> <div>1600.00</div>				Compliance		Description		Data		Compliance		Description		Data			
				N/A		Ramp Length (in)		107.5		Yes		Grade Break?		Yes			
				Yes		Ramp Width (in)		66.5		No		Grade Break Slope (%)		6.7
