Access Compliance Report

Public Rights-of-Way

(Curb Ramps)

Intersection ID: 2598	Main Street: DRISCOLL_CT	Cross Street: LAGRANDE_DR	Location:	W
ADA ID: BC029F9987A5	Ramp Type: Perp	Initial Pass/Fail: Fail	Overall Compliance: No	Severity Score: 25
Codes/Mitigation Info/Possible Solution		Field Measurements/Component Compliance

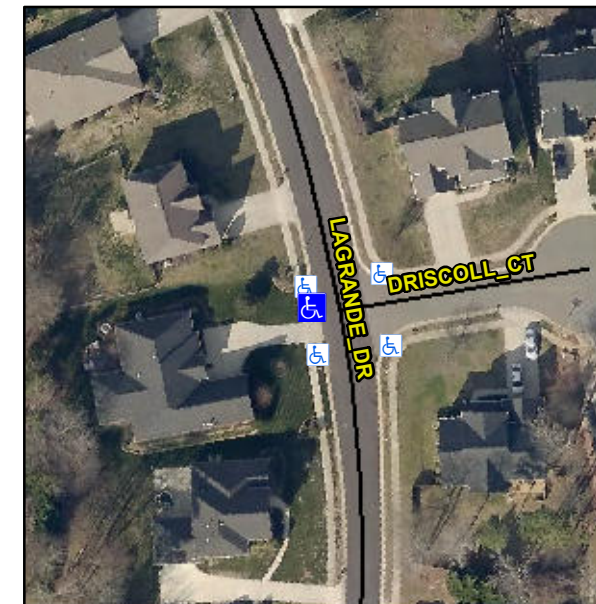
Not Found, R304.2.2, R304.5.3

Compliance	Description	Data	Compliance	Description	Data
N/A	Ramp Length (in)	46.0	No	Ramp Slope (%)	11.8
Yes	Ramp Width (in)	48.0	No	Ramp XSlope (%)	5.3
N/A	Flare Type LT	N/A	N/A	Flare Type RT	N/A
N/A	Flare Slope LT (%)	N/A	N/A	Flare Slope RT (%)	N/A
N/A	Flare Traversable LT?	N/A	N/A	Flare Traversable RT?	N/A
N/A	Landing Length (in)	N/A	N/A	DWS Provided?	N/A
N/A	Landing Width (in)	N/A	N/A	DWS Contrast?	N/A
N/A	Landing Slope (%)	N/A	N/A	DWS Length (in)	N/A
N/A	Landing X Slope (%)	N/A	N/A	DWS Full Width?	N/A
N/A	Landing Curb? (Y/N)	N/A	N/A	DWS Offset (in)	N/A
N/A	Shared Landing?	N/A			
N/A	Gutter Ponding?	N/A	N/A	Gutter Slope (%)	N/A
N/A	Gutter Lip Ht (in)	N/A	N/A	Gutter X Slope (%)	N/A
N/A	Painted X Walk1?	No	N/A	Painted X Walk2?	N/A
	X Walk 1 Direction	To E		X Walk 2 Direction	N/A
N/A	X Walk 1 Width (in)	N/A	N/A	X Walk 2 Width (in)	N/A
	X Walk 1 Slope (%)	3.5		X Walk 2 Slope (%)	N/A
	X Walk 1 X Slope (%)	3.3		X Walk 2 X Slope (%)	N/A

N/A	Ramp inside XWalk1?	N/A	N/A	Ramp inside XWalk2?	N/A
	Road Slope (%)	N/A	N/A	Clear Space?	N/A
	Road X Slope (%)	N/A	N/A	Clear Space to XWalk (in)	N/A
N/A	Any Obstructions?	N/A	N/A	Storm Grate/Utility Hazard?	N/A
	Obstruction Type			Storm Grate/Utility Type	
		N/A			N/A
			Yes	Surface Condition? (G/P)	Good

Possible Solutions:

Remove & Replace Entire Ramp.
