Access Compliance Report

Public Rights-of-Way

(Curb Ramps)

Intersection ID: 4259	Main Street: LAKEWOOD_EDGE_DR	Cross Street: RADBOURNE_BV	Location: SE
ADA ID: BC039B6D7312	Ramp Type: Directional1	Initial Pass/Fail: Fail	Overall Compliance: No
Severity Score: 22.5			
Codes/Mitigation Info/Possible Solution		Field Measurements/Component Compliance

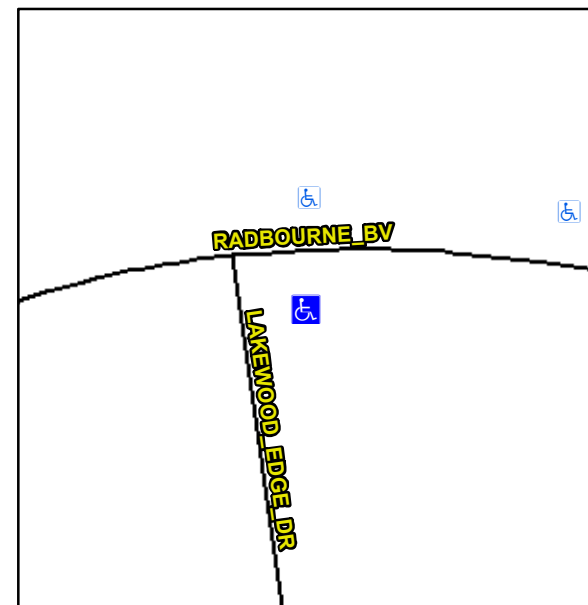
Compliance	Description	Data	Compliance	Description	Data
N/A	Ramp Length (in)	12.0	N/A	Grade Break?	N/A
No	Ramp Width (in)	47.0	N/A	Grade Break Slope (%)	0.0
No	Ramp Slope (%)	10.2	N/A	Grade Break XSlope (%)	0.0
No	Ramp XSlope (%)	3.4			
N/A	Flare Type LT	N/A	N/A	Flare Type RT	N/A
N/A	Flare Slope LT (%)	N/A	N/A	Flare Slope RT (%)	0.0
N/A	Flare Traversable LT?	N/A	N/A	Flare Traversable RT?	N/A
N/A	Landing Length (in)	0.0	N/A	DWS Provided?	N/A
N/A	Landing Width (in)	0.0	N/A	DWS Contrast?	N/A
N/A	Landing Slope (%)	0.0	N/A	DWS Length (in)	N/A
N/A	Landing X Slope (%)	0.0	N/A	DWS Full Width?	N/A
N/A	Landing Curb? (Y/N)	N/A	N/A	DWS Offset LT (in)	N/A
N/A	Shared Landing?	N/A	N/A	DWS Offset RT (in)	N/A
N/A	Gutter Ponding?	0.0	N/A	Gutter Slope (%)	N/A
N/A	Gutter Lip Ht (in)	0.0	N/A	Gutter X Slope (%)	N/A
N/A	Painted X Walk1?	No		Road Slope (%)	2.3
	X Walk 1 Direction	To N		Road X Slope (%)	3.0
	X Walk 1 Width (in)	N/A		Clear Space?	N/A

X Walk 1 Slope (%)	2.3	N/A	Clear Space to XWalk (in)	N/A
	X Walk 1 X Slope (%)	3.0	N/A	Storm Grate/Utility Hazard?	N/A
N/A	Ramp inside XWalk1?	N/A		Storm Grate/Utility Type	
N/A	Any Obstructions?	N/A			N/A
	Obstruction Type		Yes	Surface Condition? (G/P)	Good
			N/A	Curb Slope (%)	N/A

Possible Solutions:

Remove & Replace Entire Ramp.

R304.5.1, R304.2.2, R304.5.3
