Access Compliance Report

Public Rights-of-Way

(Curb Ramps)

Intersection ID: 3145	Main Street: BASKERVILLE_AV	Cross Street: PALLADIUM_PL	Location: E
ADA ID: BC0E1F6FD35F	Ramp Type: Perp	Initial Pass/Fail: Pass	Overall Compliance: No
Severity Score: 10			
Codes/Mitigation Info/Possible Solution		Field Measurements/Component Compliance

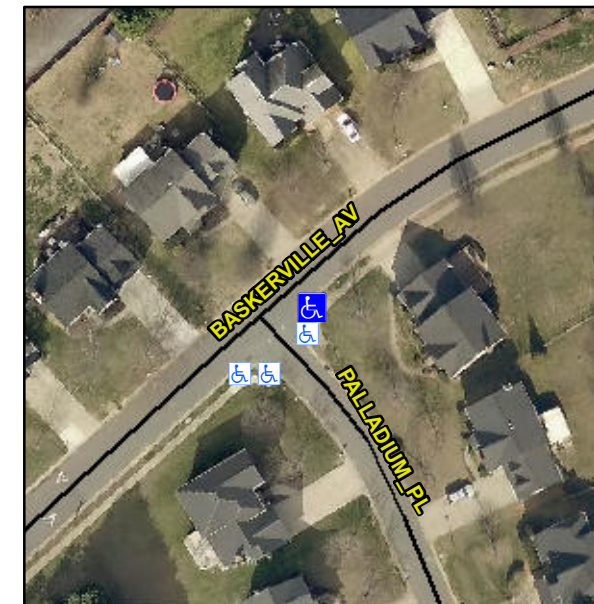
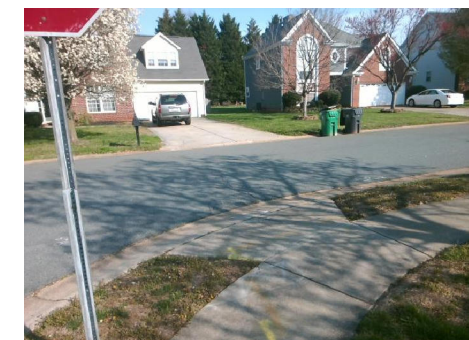
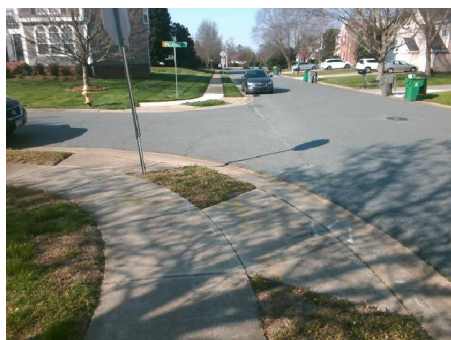
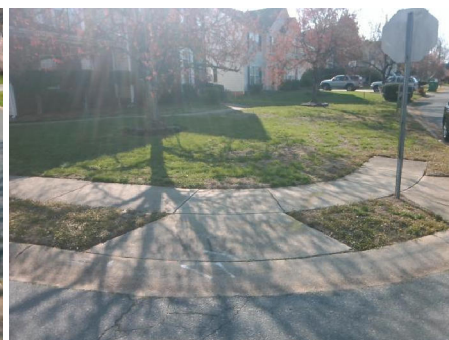
Compliance	Description	Data	Compliance	Description	Data
N/A	Ramp Length (in)	49.0	Yes	Ramp Slope (%)	6.6
Yes	Ramp Width (in)	63.0	Yes	Ramp XSlope (%)	1.4
N/A	Flare Type LT	Sloped	N/A	Flare Type RT	N/A
N/A	Flare Slope LT (%)	3.0	N/A	Flare Slope RT (%)	0.3
N/A	Flare Traversable LT?	No	N/A	Flare Traversable RT?	No
Yes	Landing Length (in)	48.0	No	DWS Provided?	No
Yes	Landing Width (in)	63.0	N/A	DWS Contrast?	No
Yes	Landing Slope (%)	0.5	N/A	DWS Length (in)	N/A
No	Landing X Slope (%)	4.0	N/A	DWS Full Width?	No
N/A	Landing Curb? (Y/N)	No	N/A	DWS Offset (in)	N/A
N/A	Shared Landing?	No			
Yes	Gutter Ponding?	No	Yes	Gutter Slope (%)	1.9
Yes	Gutter Lip Ht (in)	0.0	Yes	Gutter X Slope (%)	1.9
N/A	Painted X Walk1?	No	N/A	Painted X Walk2?	N/A
	X Walk 1 Direction	To NW		X Walk 2 Direction	N/A
N/A	X Walk 1 Width (in)	N/A	N/A	X Walk 2 Width (in)	N/A
	X Walk 1 Slope (%)	3.2		X Walk 2 Slope (%)	N/A
	X Walk 1 X Slope (%)	1.8		X Walk 2 X Slope (%)	N/A

N/A	Ramp inside XWalk1?	N/A	N/A	Ramp inside XWalk2?	N/A
	Road Slope (%)	N/A	N/A	Clear Space?	Yes
	Road X Slope (%)	N/A	N/A	Clear Space to XWalk (in)	N/A
Yes	Any Obstructions?	No	Yes	Storm Grate/Utility Hazard?	No
	Obstruction Type			Storm Grate/Utility Type	
		N/A			N/A
			Yes	Surface Condition? (G/P)	Good

Possible Solutions:

Remove & Replace Entire Ramp.

PROW/ADA:

R304.5.3, R305

Total Cost: \$ 1850.00
