# Access Compliance Report

## Public Rights-of-Way

### (Curb Ramps)

Intersection ID: 12565	Main Street: E_10TH_ST	Cross Street: E_11TH_ST	Location: NE
ADA ID: BC1624CCC5AE	Ramp Type: Perp	Initial Pass/Fail: Fail	Overall Compliance: No
		Severity Score: 12.5

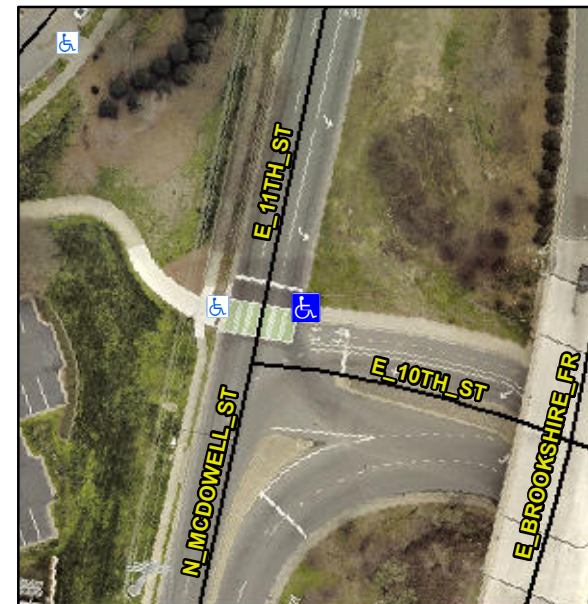
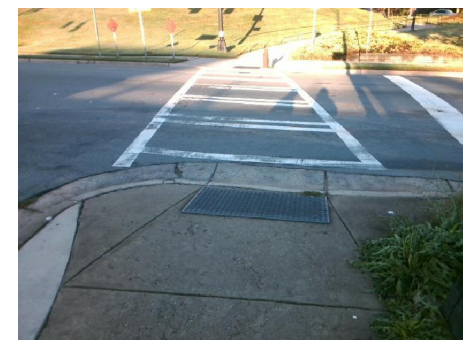
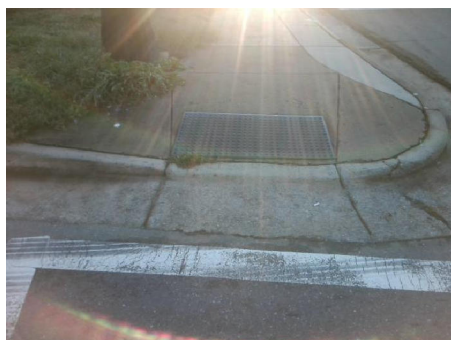
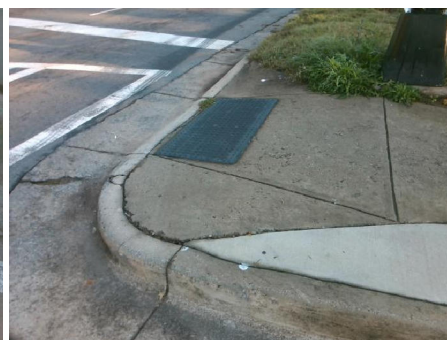
Compliance	Description	Data	Compliance	Description	Data
N/A	Ramp Length (in)	67.5	No	Ramp Slope (%)	8.4
Yes	Ramp Width (in)	48.0	Yes	Ramp XSlope (%)	1.0
N/A	Flare Type LT	N/A	N/A	Flare Type RT	N/A
N/A	Flare Slope LT (%)	N/A	N/A	Flare Slope RT (%)	N/A
N/A	Flare Traversable LT?	N/A	N/A	Flare Traversable RT?	N/A
N/A	Landing Length (in)	N/A	N/A	DWS Provided?	N/A
N/A	Landing Width (in)	N/A	N/A	DWS Contrast?	N/A
N/A	Landing Slope (%)	N/A	N/A	DWS Length (in)	N/A
N/A	Landing X Slope (%)	N/A	N/A	DWS Full Width?	N/A
N/A	Landing Curb? (Y/N)	N/A	N/A	DWS Offset (in)	N/A
N/A	Shared Landing?	N/A			
N/A	Gutter Ponding?	N/A	N/A	Gutter Slope (%)	N/A
N/A	Gutter Lip Ht (in)	N/A	N/A	Gutter X Slope (%)	N/A
N/A	Painted X Walk1?	Yes	N/A	Painted X Walk2?	N/A
	X Walk 1 Direction	To W		X Walk 2 Direction	N/A
N/A	X Walk 1 Width (in)	110.0	N/A	X Walk 2 Width (in)	N/A
	X Walk 1 Slope (%)	4.1		X Walk 2 Slope (%)	N/A
	X Walk 1 X Slope (%)	0.4		X Walk 2 X Slope (%)	N/A

**Remove & Replace Entire Ramp.**

**Not Found, R304.2.2**
