Access Compliance Report

Public Rights-of-Way

(Curb Ramps)

Intersection ID: 12489	Main Street: CHESTNUT_AV	Cross Street: NASSAU_BV	Location: SW
ADA ID: BC1E99115450	Ramp Type: PerpDiag	Initial Pass/Fail: Fail	Overall Compliance: No
		Severity Score: 10

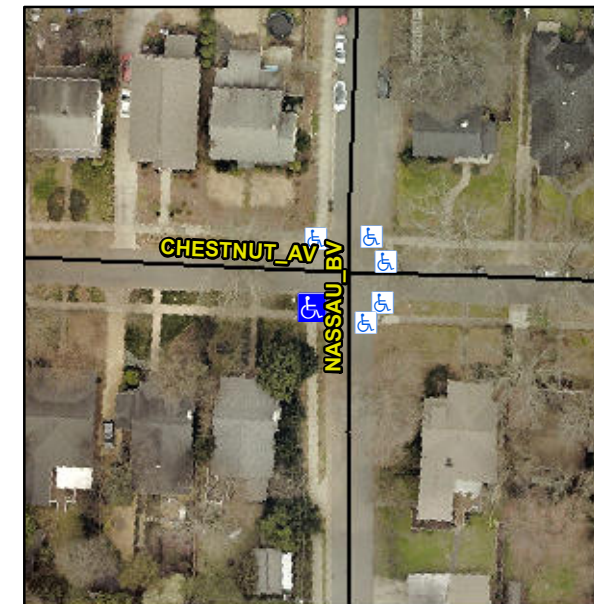
Not Found, R304.5.1, R304.5.3

Compliance	Description	Data	Compliance	Description	Data
N/A	Ramp Length (in)	48.0	Yes	Ramp Slope (%)	6.2
No	Ramp Width (in)	47.0	No	Ramp XSlope (%)	3.3
N/A	Flare Type LT	N/A	N/A	Flare Type RT	N/A
N/A	Flare Slope LT (%)	N/A	N/A	Flare Slope RT (%)	N/A
N/A	Flare Traversable LT?	N/A	N/A	Flare Traversable RT?	N/A
N/A	Landing Length (in)	N/A	N/A	DWS Provided?	N/A
N/A	Landing Width (in)	N/A	N/A	DWS Contrast?	N/A
N/A	Landing Slope (%)	N/A	N/A	DWS Length (in)	N/A
N/A	Landing X Slope (%)	N/A	N/A	DWS Full Width?	N/A
N/A	Landing Curb? (Y/N)	N/A	N/A	DWS Offset (in)	N/A
N/A	Shared Landing?	N/A			
N/A	Gutter Ponding?	Yes	N/A	Gutter Slope (%)	N/A
N/A	Gutter Lip Ht (in)	N/A	N/A	Gutter X Slope (%)	N/A
N/A	Painted X Walk1?	No	N/A	Painted X Walk2?	No
	X Walk 1 Direction	To E		X Walk 2 Direction	To N
N/A	X Walk 1 Width (in)	N/A	N/A	X Walk 2 Width (in)	N/A
	X Walk 1 Slope (%)	1.6		X Walk 2 Slope (%)	5.4
	X Walk 1 X Slope (%)	1.8		X Walk 2 X Slope (%)	4.4

N/A	Ramp inside XWalk1?	N/A	N/A	Ramp inside XWalk2?	N/A
	Road Slope (%)	4.9	N/A	Clear Space?	N/A
	Road X Slope (%)	2.9	N/A	Clear Space to XWalk (in)	N/A
N/A	Any Obstructions?	N/A	N/A	Storm Grate/Utility Hazard?	N/A
	Obstruction Type			Storm Grate/Utility Type	
		N/A			N/A
		Yes		Surface Condition? (G/P)	Good

Remove & Replace Curb Ramp With Two New Directional Ramps or Equivalent.
