# Access Compliance Report

## Public Rights-of-Way (Curb Ramps)

Intersection ID: N/A	Main Street: ARROWOOD_RD	Cross Street: MICROSOFT_WY	Location: SE
ADA ID: BC21ADC5AA2A	Ramp Type: Perp	Initial Pass/Fail: Pass	Overall Compliance: No
Codes/Mitigation Info/Possible Solution			Severity Score: 30
			Field Measurements/Component Compliance

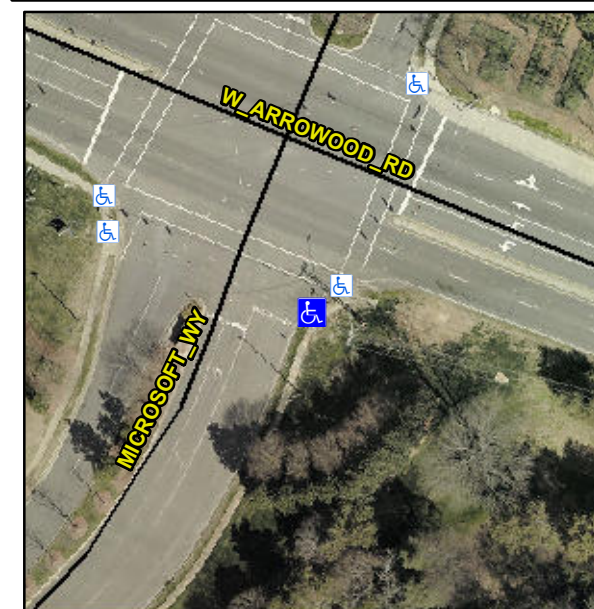
Compliance	Description	Data	Compliance	Description	Data
N/A	Ramp Length (in)	54.0	Yes	Ramp Slope (%)	8.0
Yes	Ramp Width (in)	48.0	Yes	Ramp XSlope (%)	1.5
N/A	Flare Type LT	Sloped	N/A	Flare Type RT	N/A
N/A	Flare Slope LT (%)	6.1	Yes	Flare Slope RT (%)	4.2
N/A	Flare Traversable LT?	Yes	N/A	Flare Traversable RT?	Yes
No	Landing Length (in)	40.0	No	DWS Provided?	No
Yes	Landing Width (in)	48.0	N/A	DWS Contrast?	No
No	Landing Slope (%)	3.3	N/A	DWS Length (in)	N/A
Yes	Landing X Slope (%)	0.7	N/A	DWS Full Width?	No
N/A	Landing Curb? (Y/N)	No	N/A	DWS Offset (in)	N/A
N/A	Shared Landing?	No			
No	Gutter Ponding?	Yes	No	Gutter Slope (%)	5.2
No	Gutter Lip Ht (in)	1.0	Yes	Gutter X Slope (%)	0.9
N/A	Painted X Walk1?	No	N/A	Painted X Walk2?	N/A
	X Walk 1 Direction	To NW		X Walk 2 Direction	N/A
N/A	X Walk 1 Width (in)	N/A	N/A	X Walk 2 Width (in)	N/A
	X Walk 1 Slope (%)	2.3		X Walk 2 Slope (%)	N/A
	X Walk 1 X Slope (%)	0.3		X Walk 2 X Slope (%)	N/A

Possible Solutions:

**Remove & Replace Entire Ramp.  
Remove & Replace Gutter.**

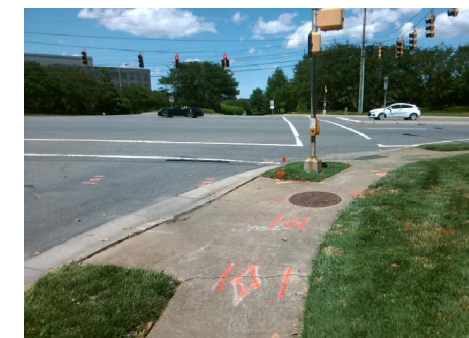
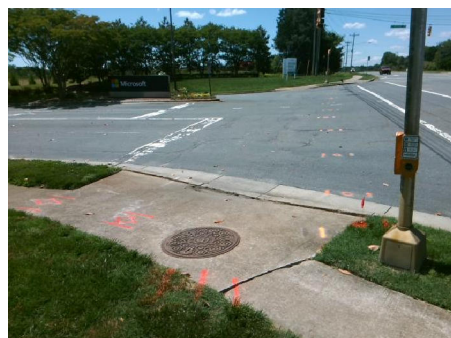
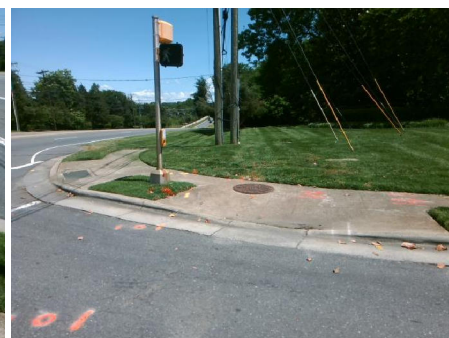
N/A	Ramp inside XWalk1?	N/A	N/A	Ramp inside XWalk2?	N/A
	Road Slope (%)	N/A	N/A	Clear Space?	Yes
	Road X Slope (%)	N/A	N/A	Clear Space to XWalk (in)	N/A
Yes	Any Obstructions?	No	Yes	Storm Grate/Utility Hazard?	No
	Obstruction Type			Storm Grate/Utility Type	
		N/A			N/A
		Yes	Yes	Surface Condition? (G/P)	Good
