Access Compliance Report

Public Rights-of-Way

(Curb Ramps)

Intersection ID: 12320	Main Street: ALLEN_ST	Cross Street: BELMONT_AV	Location:	N
ADA ID: BC237178AE4D	Ramp Type: BlendTrans1	Initial Pass/Fail: Fail	Overall Compliance: No	Severity Score: 8.75
Codes/Mitigation Info/Possible Solution		Field Measurements/Component Compliance

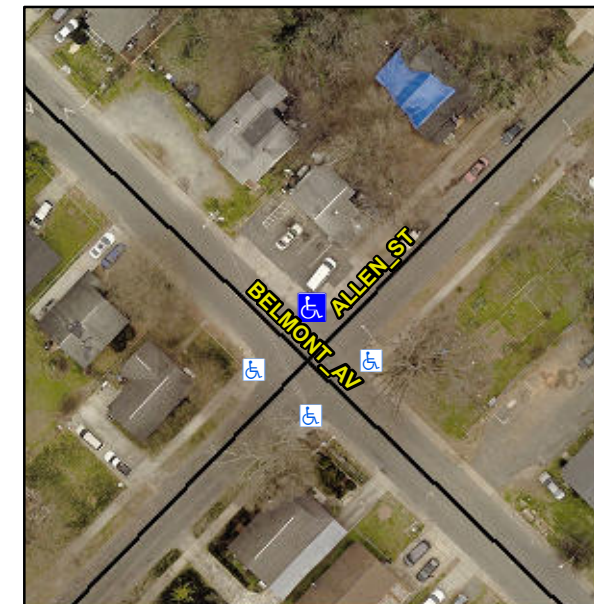
Compliance	Description	Data	Compliance	Description	Data
N/A	Ramp Length (in)	74.5	Yes	BlendTrans Slope (%)	1.7
No	Ramp Width (in)	47.0	Yes	BlendTrans XSlope (%)	0.1
N/A	Flare Type LT	N/A	N/A	Flare Type RT	N/A
N/A	Flare Slope LT (%)	N/A	N/A	Flare Slope RT (%)	N/A
N/A	Flare Traversable LT?	N/A	N/A	Flare Traversable RT?	N/A
N/A	Landing Length (in)	N/A	N/A	DWS Provided?	N/A
N/A	Landing Width (in)	N/A	N/A	DWS Contrast?	N/A
N/A	Landing Slope (%)	N/A	N/A	DWS Length (in)	N/A
N/A	Landing X Slope (%)	N/A	N/A	DWS Full Width?	N/A
N/A	Landing Curb? (Y/N)	N/A	N/A	DWS Offset (in)	N/A
N/A	Shared Landing?	N/A			
N/A	Gutter Ponding?	N/A	N/A	Gutter Slope (%)	N/A
N/A	Gutter Lip Ht (in)	1.0	N/A	Gutter X Slope (%)	N/A
N/A	Painted X Walk1?	No	N/A	Painted X Walk2?	No
	X Walk 1 Direction	To SW		X Walk 2 Direction	To SE
	X Walk 1 Width (in)	N/A		X Walk 2 Width (in)	N/A
	X Walk 1 Slope (%)	0.9		X Walk 2 Slope (%)	4.2
	X Walk 1 X Slope (%)	2.9		X Walk 2 X Slope (%)	0.9

N/A	Ramp inside XWalk1?	N/A	N/A	Ramp inside XWalk2?	N/A
	Road Slope (%)	0.7		Clear Space?	N/A
	Road X Slope (%)	3.2	N/A	Clear Space to XWalk (in)	N/A
N/A	Any Obstructions?	N/A	N/A	Storm Grate/Utility Hazard?	N/A
	Obstruction Type			Storm Grate/Utility Type	
		N/A			N/A
			Yes	Surface Condition? (G/P)	Good
			N/A	Curb Slope (%)	1.6

Possible Solutions:

Remove & Replace Curb Ramp With Two New Directional Ramps or Equivalent.

R304.5.1

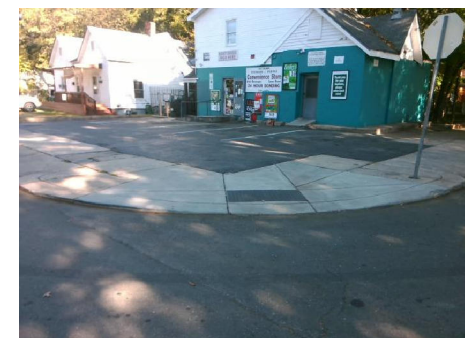
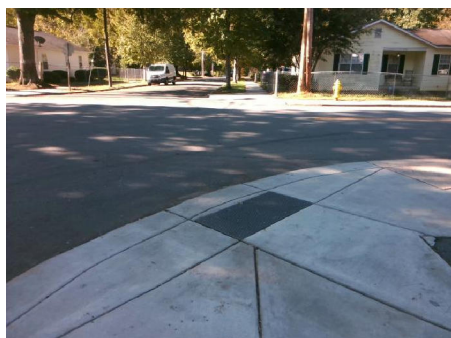
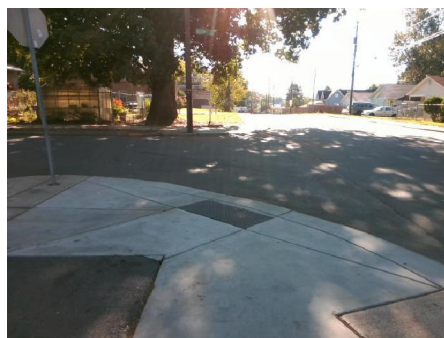
Street 1 Name **BELMONT AV**
 Stop Condition-Street 1 **None**
 Street 2 Name **ALLEN ST**
 Stop Condition-Street 2 **StopSign**
