# Access Compliance Report

## Public Rights-of-Way (Curb Ramps)

| Intersection ID: 4026 | Main Street: CLAYBROOKE_DR | Cross Street: GALLOWAY_RD | Location: SW |
| ADA ID: BC24A13C2C29 | Ramp Type: Perp | Initial Pass/Fail: Fail | Overall Compliance: No |

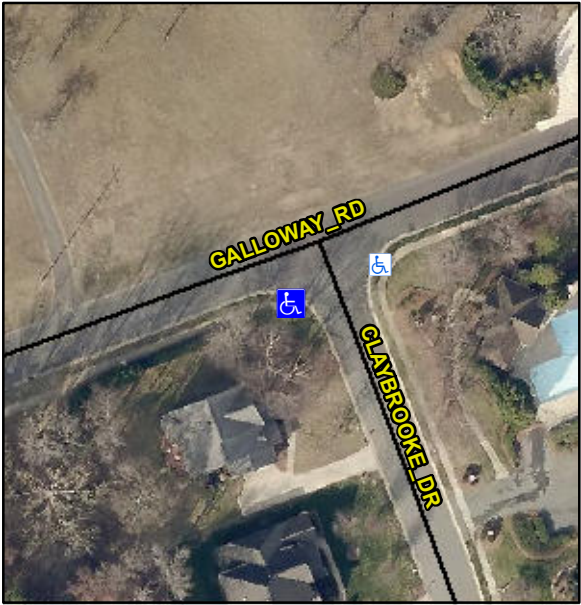
| | | Severity Score: 22.5 | |

| Codes/Mitigation Info/Possible Solution | | | Field Measurements/Component Compliance | | | |
|---|---|---|---|---|---|---|
| | <b>Remove &amp; Replace Entire Ramp.</b> | | <b>No</b> | Ramp Length (in) | <b>97.0</b> | <b>No</b> |
| | | | <b>No</b> | Ramp Width (in) | <b>47.5</b> | <b>No</b> |
| <p>Surveyor Notes:</p> <p><b>N/A</b></p> <p>PROW/ADA:</p> <p><b>R304.5.1, R304.2.2, R304.5.3</b></p> | | | <b>N/A</b> | Road Slope (%) | <b>N/A</b> | <b>N/A</b> |

| Codes/Mitigation Info/Possible Solution | | | Field Measurements/Component Compliance | | | |
|---|---|---|---|---|---|---|
| | Possible Solutions: | | <b>Compliance</b> | <b>Description</b> | <b>Data</b> | <b>Compliance</b> |
| Total Cost: | | \$ 1850.00 | | | | |
