## Access Compliance Report Public Rights-of-Way (Curb Ramps)

Intersection ID: 28773 Main S	Main Street: ROYAL_HIGHLANDS_CT			THATCHER_HALL_C		Location:	SE	
ADA ID: BC24CC00907E Ramp	Ramp Type: Perp			ail: Pass Overall	ce: N	o Severity Score:	15	
Codes/Mitigation Info/Possible Solution			Field Measurements/Component Compliance					
	Possible Solutions:		Compliance Description			Data Compliance Description		
	Remove & Replace Entire Ramp.		N/A	Ramp Length (in)	47.5	Yes	Ramp Slope (%)	6.6
	Remove & Replace Gutter.		Yes	Ramp Width (in)	60.0	Yes	Ramp XSlope (%)	1.1
			N/A	Flare Type LT	Sloped	N/A	Flare Type RT	N/A
			N/A	Flare Slope LT (%)	3.0	Yes	Flare Slope RT (%)	6.0
			N/A	Flare Traversable LT?	Yes	N/A	Flare Traversable RT?	Yes
			No	Landing Length (in)	47.5	No	DWS Provided?	No
THATCHER HOLL OF	Surveyor Notes:		Yes	Landing Width (in)	60.0	N/A	DWS Contrast?	No
	N/A		No	Landing Slope (%)	2.4	N/A	DWS Length (in)	N/A
			Yes	Landing X Slope (%)	1.1	N/A	DWS Full Width?	No

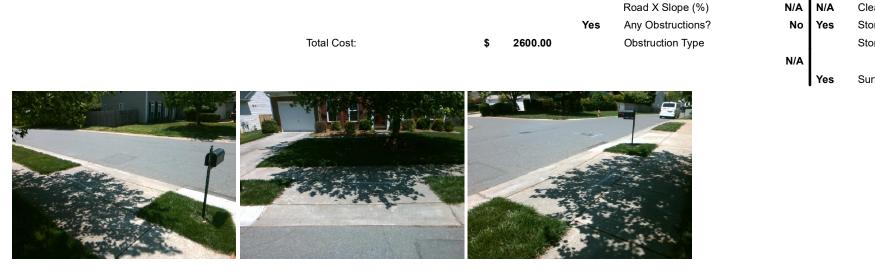
N/A	Landing Curb? (Y/N)	No	N/A	DWS Offset (in)	N/A
1 1 1 1 1 1 1			N/A	Shared Landing?	No			
	PROW/ADA:		Yes	Gutter Ponding?	No	No	Gutter Slope (%)	5.4
	Not Found, R304.2.1, R304.2.2-Pe	erp,	Yes	Gutter Lip Ht (in)	0.0	Yes	Gutter X Slope (%)	1.8
	R304.3.2-Para, R305, R304.5.4	• *	N/A	Painted X Walk1?	No	N/A	Painted X Walk2?	N/A
				X Walk 1 Direction	To W		X Walk 2 Direction	N/A
CARLE CARLENAL MERICE			N/A	X Walk 1 Width (in)	N/A	N/A	X Walk 2 Width (in)	N/A
Street 1 Name ROYAL HIGHLANDS CT	r			X Walk 1 Slope (%)	2.9		X Walk 2 Slope (%)	N/A
Stop Condition-Street 2 None				X Walk 1 X Slope (%)	1.6		X Walk 2 X Slope (%)	N/A
Street 2 Name N/A	A Contraction of the second seco		N/A	Ramp inside XWalk1?	N/A	N/A	Ramp inside XWalk2?	N/A
Stop Condition-Street 1 N/A	A Contraction of the second seco			Road Slope (%)	N/A	N/A	Clear Space?	Yes
				Road X Slope (%)	N/A	N/A	Clear Space to XWalk (in)	N/A
			Yes	Any Obstructions?	No	Yes	Storm Grate/Utility Hazard?	No

s Surface Condition? (G/P)

Good
