Access Compliance Report

Public Rights-of-Way

(Curb Ramps)

Intersection ID: 49297	Main Street: CAMPBELL_HALL_CT	Cross Street: CHAMBERLIN_RD	Location: SW
ADA ID: BC28013DA509	Ramp Type: Perp	Initial Pass/Fail: Fail	Overall Compliance: No
Severity Score: 26.25			
Codes/Mitigation Info/Possible Solution		Field Measurements/Component Compliance

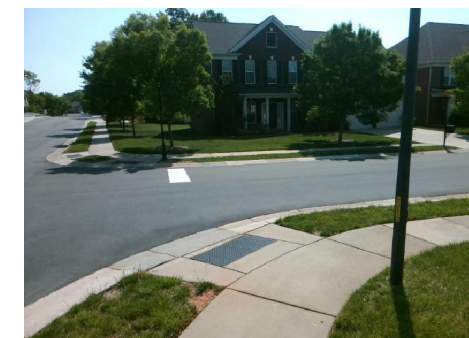
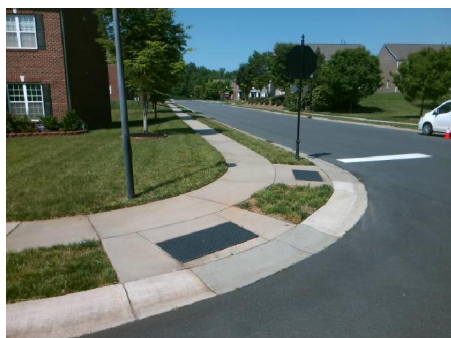
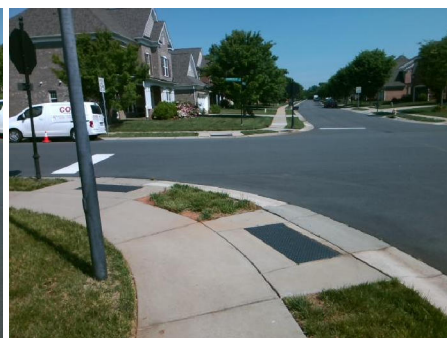
Not Found, R304.2.2, R304.5.3

Compliance	Description	Data	Compliance	Description	Data
N/A	Ramp Length (in)	48.0	No	Ramp Slope (%)	16.4
Yes	Ramp Width (in)	48.0	No	Ramp XSlope (%)	2.8
N/A	Flare Type LT	N/A	N/A	Flare Type RT	N/A
N/A	Flare Slope LT (%)	N/A	N/A	Flare Slope RT (%)	N/A
N/A	Flare Traversable LT?	N/A	N/A	Flare Traversable RT?	N/A
N/A	Landing Length (in)	N/A	N/A	DWS Provided?	N/A
N/A	Landing Width (in)	N/A	N/A	DWS Contrast?	N/A
N/A	Landing Slope (%)	N/A	N/A	DWS Length (in)	N/A
N/A	Landing X Slope (%)	N/A	N/A	DWS Full Width?	N/A
N/A	Landing Curb? (Y/N)	N/A	N/A	DWS Offset (in)	N/A
N/A	Shared Landing?	N/A			
N/A	Gutter Ponding?	N/A	N/A	Gutter Slope (%)	N/A
N/A	Gutter Lip Ht (in)	N/A	N/A	Gutter X Slope (%)	N/A
N/A	Painted X Walk1?	No	N/A	Painted X Walk2?	N/A
	X Walk 1 Direction	To NE		X Walk 2 Direction	N/A
N/A	X Walk 1 Width (in)	N/A	N/A	X Walk 2 Width (in)	N/A
	X Walk 1 Slope (%)	0.1		X Walk 2 Slope (%)	N/A
	X Walk 1 X Slope (%)	2.5		X Walk 2 X Slope (%)	N/A

N/A	Ramp inside XWalk1?	N/A	N/A	Ramp inside XWalk2?	N/A
	Road Slope (%)	N/A	N/A	Clear Space?	N/A
	Road X Slope (%)	N/A	N/A	Clear Space to XWalk (in)	N/A
N/A	Any Obstructions?	N/A	N/A	Storm Grate/Utility Hazard?	N/A
	Obstruction Type			Storm Grate/Utility Type	
		N/A			N/A
			Yes	Surface Condition? (G/P)	Good

Remove & Replace Entire Ramp.

Total Cost: \$ 1850.00
