## **Access Compliance Report Public Rights-of-Way** (Curb Ramps)

Intersection ID: 10030 Main Street: E 28TH ST **Cross Street: N TRYON ST** Location: NW

ADA ID: BC2919A70D92 Ramp Type: PerpDiag Initial Pass/Fail: Fail **Overall Compliance: No** Severity Score: 33.75

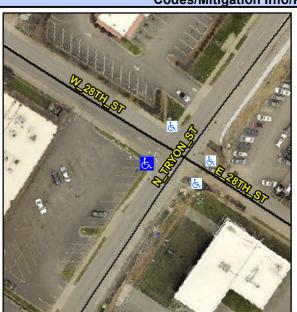
ried Measurements/Component Comphance						
	Compliance Description		Data	Compliance Description		Data
	N/A	Ramp Length (in)	33.0	No	Ramp Slope (%)	13.1
	No	Ramp Width (in)	39.0	Yes	Ramp XSlope (%)	0.3
	N/A	Flare Type LT	N/A	N/A	Flare Type RT	N/A
	N/A	Flare Slope LT (%)	N/A	N/A	Flare Slope RT (%)	N/A
	N/A	Flare Traversable LT?	N/A	N/A	Flare Traversable RT?	N/A
	N/A	Landing Length (in)	N/A	N/A	DWS Provided?	N/A
	N/A	Landing Width (in)	N/A	N/A	DWS Contrast?	N/A
	N/A	Landing Slope (%)	N/A	N/A	DWS Length (in)	N/A
	N/A	Landing X Slope (%)	N/A	N/A	DWS Full Width?	N/A
	N/A	Landing Curb? (Y/N)	N/A	N/A	DWS Offset (in)	N/A
	N/A	Shared Landing?	N/A			
	N/A	Gutter Ponding?	N/A	N/A	Gutter Slope (%)	N/A
	N/A	Gutter Lip Ht (in)	1.5	N/A	Gutter X Slope (%)	N/A
	N/A	Painted X Walk1?	Yes	N/A	Painted X Walk2?	Yes
		X Walk 1 Direction	To SE		X Walk 2 Direction	To NE
	N/A	X Walk 1 Width (in)	102.0	N/A	X Walk 2 Width (in)	112.5

X Walk 1 Slope (%)	1.9		X Walk 2 Slope (%)	2.3
		X Walk 1 X Slope (%)	3.8		X Walk 2 X Slope (%)	1.0
	N/A	Ramp inside XWalk1?	Yes	N/A	Ramp inside XWalk2?	Yes
		Road Slope (%)	4.3	N/A	Clear Space?	N/A
		Road X Slope (%)	2.3	N/A	Clear Space to XWalk (in)	N/A
	N/A	Any Obstructions?	N/A	N/A	Storm Grate/Utility Hazard?	N/A

Possible Solutions: Remove & Replace Curb Ramp With **Two New Directional Ramps or** Equivalent. Surveyor Notes: N/A PROW/ADA: Not Found, R304.5.1, R304.2.2
