# Access Compliance Report

## Public Rights-of-Way

### (Curb Ramps)

Intersection ID: 30342	Main Street: GOLD_PAN_RD	Cross Street: SANDBOAR_ST	Location: SE
ADA ID: BC2D494A6C29	Ramp Type: BlendTrans1	Initial Pass/Fail: Fail	Overall Compliance: No
Codes/Mitigation Info/Possible Solution			Severity Score: 10
			Field Measurements/Component Compliance

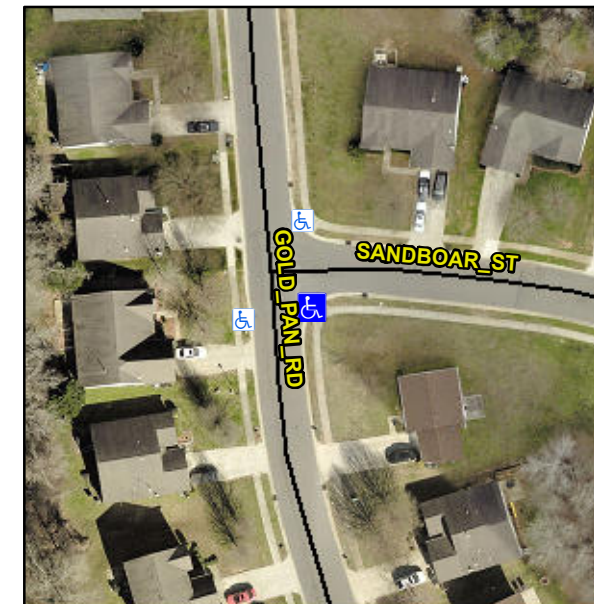
Compliance	Description	Data	Compliance	Description	Data
N/A	Ramp Length (in)	55.0	Yes	BlendTrans Slope (%)	4.0
No	Ramp Width (in)	47.5	No	BlendTrans XSlope (%)	2.3
N/A	Flare Type LT	N/A	N/A	Flare Type RT	N/A
N/A	Flare Slope LT (%)	N/A	N/A	Flare Slope RT (%)	N/A
N/A	Flare Traversable LT?	N/A	N/A	Flare Traversable RT?	N/A
N/A	Landing Length (in)	N/A	N/A	DWS Provided?	N/A
N/A	Landing Width (in)	N/A	N/A	DWS Contrast?	N/A
N/A	Landing Slope (%)	N/A	N/A	DWS Length (in)	N/A
N/A	Landing X Slope (%)	N/A	N/A	DWS Full Width?	N/A
N/A	Landing Curb? (Y/N)	N/A	N/A	DWS Offset (in)	N/A
N/A	Shared Landing?	N/A			
N/A	Gutter Ponding?	N/A	N/A	Gutter Slope (%)	N/A
N/A	Gutter Lip Ht (in)	1.5	N/A	Gutter X Slope (%)	N/A
N/A	Painted X Walk1?	No	N/A	Painted X Walk2?	No
	X Walk 1 Direction	To N		X Walk 2 Direction	To W
	X Walk 1 Width (in)	N/A		X Walk 2 Width (in)	N/A
	X Walk 1 Slope (%)	0.7		X Walk 2 Slope (%)	1.4
	X Walk 1 X Slope (%)	3.1		X Walk 2 X Slope (%)	0.8

N/A	Ramp inside XWalk1?	N/A	N/A	Ramp inside XWalk2?	N/A
	Road Slope (%)	2.4		Clear Space?	N/A
	Road X Slope (%)	0.7	N/A	Clear Space to XWalk (in)	N/A
N/A	Any Obstructions?	N/A	N/A	Storm Grate/Utility Hazard?	N/A
	Obstruction Type			Storm Grate/Utility Type	
		N/A			N/A
			Yes	Surface Condition? (G/P)	Good
			No	Curb Slope (%)	16.0

Possible Solutions:

**Remove & Replace Curb Ramp With Two New Directional Ramps or Equivalent.**
