# Access Compliance Report

## Public Rights-of-Way

### (Curb Ramps)

Intersection ID: 5273	Main Street: GROVE LAKE DR	Cross Street: GROVE CREST LN	Location: W
ADA ID: BC315AAC076D	Ramp Type: PerpDiag	Initial Pass/Fail: Fail	Overall Compliance: No
			Severity Score: 55

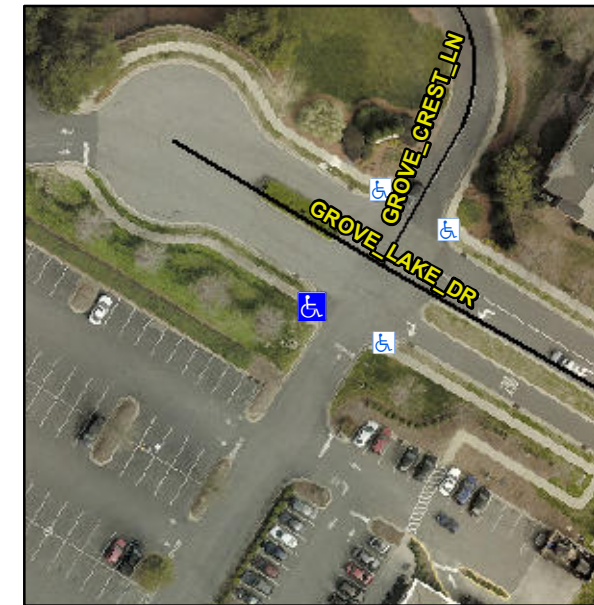
Compliance	Description	Data	Compliance	Description	Data
N/A	Ramp Length (in)	96.0	No	Ramp Slope (%)	20.0
No	Ramp Width (in)	35.0	No	Ramp XSlope (%)	5.4
N/A	Flare Type LT	N/A	N/A	Flare Type RT	N/A
N/A	Flare Slope LT (%)	N/A	N/A	Flare Slope RT (%)	N/A
N/A	Flare Traversable LT?	N/A	N/A	Flare Traversable RT?	N/A
N/A	Landing Length (in)	N/A	N/A	DWS Provided?	N/A
N/A	Landing Width (in)	N/A	N/A	DWS Contrast?	N/A
N/A	Landing Slope (%)	N/A	N/A	DWS Length (in)	N/A
N/A	Landing X Slope (%)	N/A	N/A	DWS Full Width?	N/A
N/A	Landing Curb? (Y/N)	N/A	N/A	DWS Offset (in)	N/A
N/A	Shared Landing?	N/A			
N/A	Gutter Ponding?	N/A	N/A	Gutter Slope (%)	N/A
N/A	Gutter Lip Ht (in)	N/A	N/A	Gutter X Slope (%)	N/A
N/A	Painted X Walk1?	No	N/A	Painted X Walk2?	No
	X Walk 1 Direction	To SE		X Walk 2 Direction	To NE
N/A	X Walk 1 Width (in)	N/A	N/A	X Walk 2 Width (in)	N/A
	X Walk 1 Slope (%)	2.7		X Walk 2 Slope (%)	5.8
	X Walk 1 X Slope (%)	5.5		X Walk 2 X Slope (%)	2.5

N/A	Ramp inside XWalk1?	N/A	N/A	Ramp inside XWalk2?	N/A
	Road Slope (%)	6.0	N/A	Clear Space?	N/A
	Road X Slope (%)	3.7	N/A	Clear Space to XWalk (in)	N/A
N/A	Any Obstructions?	N/A	N/A	Storm Grate/Utility Hazard?	N/A
	Obstruction Type			Storm Grate/Utility Type	
		N/A			N/A
			Yes	Surface Condition? (G/P)	Good

**Remove & Replace Curb Ramp With Two New Directional Ramps or Equivalent.**

**R304.5.1, R304.2.2, R304.5.3**
