Access Compliance Report

Public Rights-of-Way

(Curb Ramps)

Intersection ID: N/A	Main Street: LANCASTER_HY	Cross Street: WYNHOLLOW_DOWNS_LN	Location: SE
ADA ID: BC3F4F1ABDB9	Ramp Type: ParaDiag	Initial Pass/Fail: Fail	Overall Compliance: No
Codes/Mitigation Info/Possible Solution		Field Measurements/Component Compliance	
Severity Score: 26.25

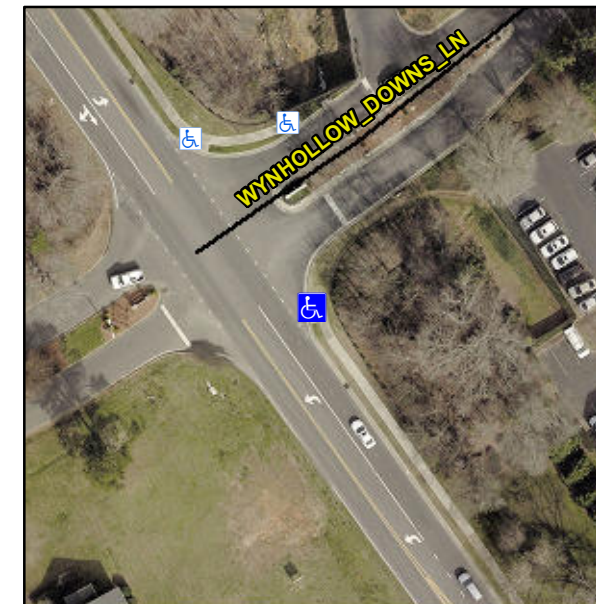
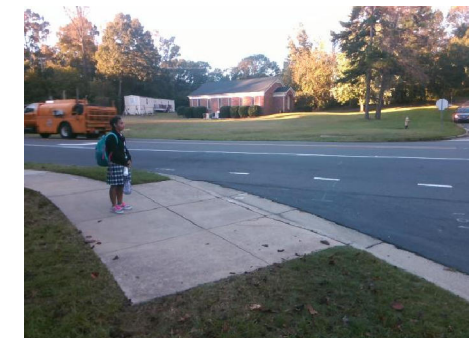
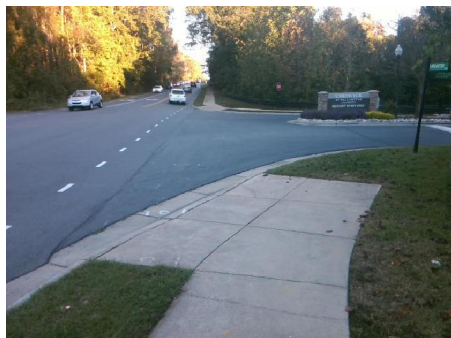
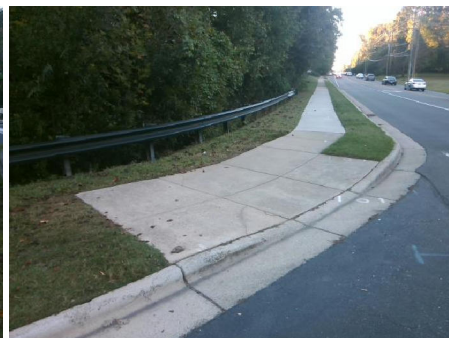
LT RP < 5%

R304.3.2, R304.5.3

Compliance	Description	Data	Compliance	Description	Data
N/A	Ramp Length LT (in)	57.5	N/A	Ramp Length RT (in)	61.0
Yes	Ramp Width LT (in)	107.0	Yes	Ramp Width RT (in)	108.0
Yes	Ramp Slope LT (%)	1.7	No	Ramp Slope RT (%)	12.5
Yes	Ramp XSlope LT (%)	1.2	No	Ramp XSlope RT (%)	2.5
N/A	Landing Length (in)	N/A	N/A	DWS Provided?	N/A
N/A	Landing Width (in)	N/A	N/A	DWS Contrast?	N/A
N/A	Landing Slope (%)	N/A	N/A	DWS Length (in)	N/A
N/A	Landing X Slope (%)	N/A	N/A	DWS Full Width?	N/A
N/A	Landing Curb? (Y/N)	N/A	N/A	DWS Offset (in)	N/A
N/A	Shared Landing?	N/A			
N/A	Gutter Ponding?	N/A	N/A	Gutter Slope (%)	N/A
N/A	Gutter Lip Ht (in)	N/A	N/A	Gutter X Slope (%)	N/A
N/A	Painted X Walk1?	No	N/A	Painted X Walk2?	No
	X Walk 1 Direction	To NW		X Walk 2 Direction	To SW
N/A	X Walk 1 Width (in)	N/A	N/A	X Walk 2 Width (in)	N/A
	X Walk 1 Slope (%)	0.9		X Walk 2 Slope (%)	2.6
	X Walk 1 X Slope (%)	5.6		X Walk 2 X Slope (%)	2.3
N/A	Ramp inside XWalk1?	N/A	N/A	Ramp inside XWalk2?	N/A

Road Slope (%)	2.4	N/A	Clear Space?	N/A
	Road X Slope (%)	0.6	N/A	Clear Space to XWalk (in)	N/A
N/A	Any Obstructions?	N/A	N/A	Storm Grate/Utility Hazard?	N/A
	Obstruction Type			Storm Grate/Utility Type	
		N/A			N/A
			Yes	Surface Condition? (G/P)	Good
			N/A	Curb Slope (%)	12.9

Remove & Replace Curb Ramp With Two New Directional Ramps or Equivalent.
