# Access Compliance Report

## Public Rights-of-Way

### (Curb Ramps)

| Intersection ID: 48453 | Main Street: ALVARADO_WY | Cross Street: RED_RUST_LN | Location: NW |

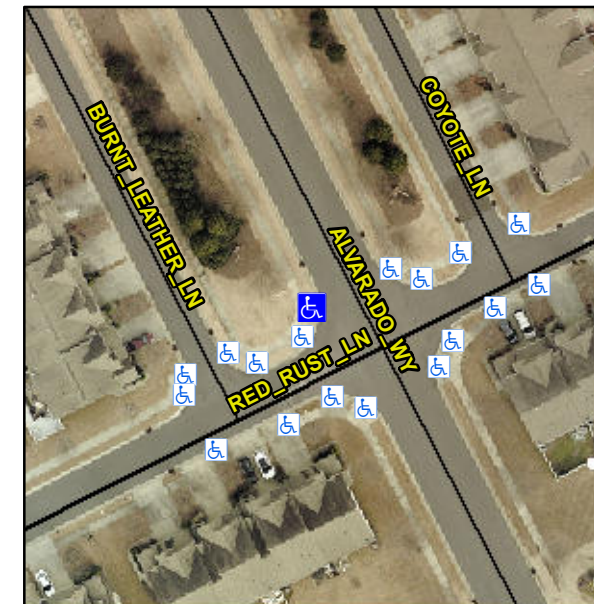
| ADA ID: BC421B79A284 | Ramp Type: Perp | Initial Pass/Fail: Fail | Overall Compliance: No |

**R304.5.1, R304.5.3**

| Compliance | Description | Data | Compliance | Description | Data |
|---|---|---|---|---|---|
| N/A | Ramp Length (in) | 133.0 | Yes | Ramp Slope (%) | 5.2 |
| No | Ramp Width (in) | 46.5 | No | Ramp XSlope (%) | 5.7 |

**Remove & Replace Entire Ramp.**

Total Cost: \$ 1850.00
