Access Compliance Report

Public Rights-of-Way

(Curb Ramps)

Intersection ID: 4964	Main Street: BREEZY_MORN_LN	Cross Street: HEDGECREST_PL	Location: S
ADA ID: BC4C4ADED3AC	Ramp Type: Perp	Initial Pass/Fail: Fail	Overall Compliance: No
		Severity Score: 25

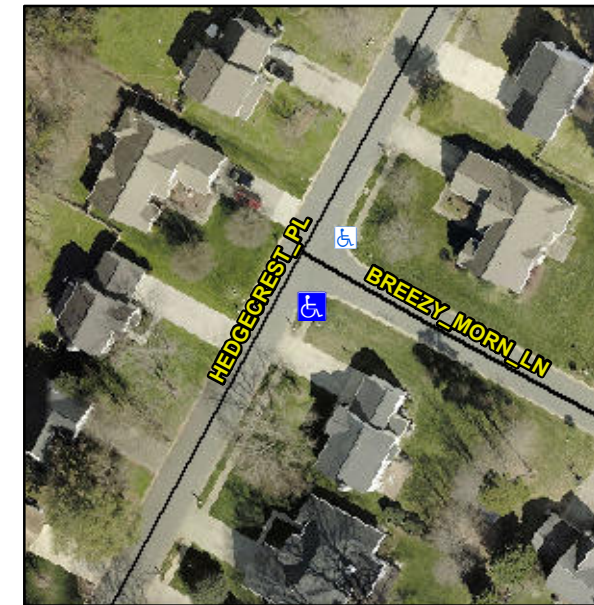
Not Found, R304.2.2

Compliance	Description	Data	Compliance	Description	Data
N/A	Ramp Length (in)	50.0	No	Ramp Slope (%)	19.7
Yes	Ramp Width (in)	48.0	Yes	Ramp XSlope (%)	2.0
N/A	Flare Type LT	N/A	N/A	Flare Type RT	N/A
N/A	Flare Slope LT (%)	N/A	N/A	Flare Slope RT (%)	N/A
N/A	Flare Traversable LT?	N/A	N/A	Flare Traversable RT?	N/A
N/A	Landing Length (in)	N/A	N/A	DWS Provided?	N/A
N/A	Landing Width (in)	N/A	N/A	DWS Contrast?	N/A
N/A	Landing Slope (%)	N/A	N/A	DWS Length (in)	N/A
N/A	Landing X Slope (%)	N/A	N/A	DWS Full Width?	N/A
N/A	Landing Curb? (Y/N)	N/A	N/A	DWS Offset (in)	N/A
N/A	Shared Landing?	N/A			
N/A	Gutter Ponding?	N/A	N/A	Gutter Slope (%)	N/A
N/A	Gutter Lip Ht (in)	N/A	N/A	Gutter X Slope (%)	N/A
N/A	Painted X Walk1?	No	N/A	Painted X Walk2?	N/A
	X Walk 1 Direction	To NE		X Walk 2 Direction	N/A
N/A	X Walk 1 Width (in)	N/A	N/A	X Walk 2 Width (in)	N/A
	X Walk 1 Slope (%)	6.1		X Walk 2 Slope (%)	N/A
	X Walk 1 X Slope (%)	2.7		X Walk 2 X Slope (%)	N/A

Remove & Replace Entire Ramp.
