Access Compliance Report

Public Rights-of-Way

(Curb Ramps)

Intersection ID: 31226	Main Street: HIDDEN_CT	Cross Street: MANGLA_DR	Location: S
ADA ID: BC53F8CE6E37	Ramp Type: PerpDiag	Initial Pass/Fail: Fail	Overall Compliance: No
Severity Score: 21.25			
Codes/Mitigation Info/Possible Solution		Field Measurements/Component Compliance

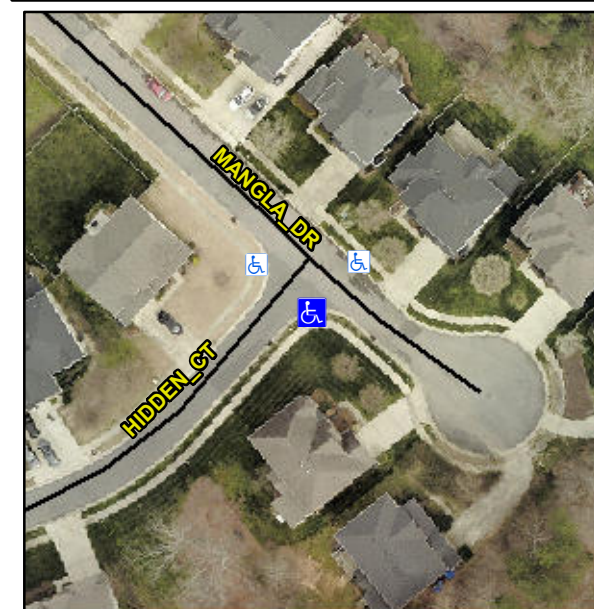
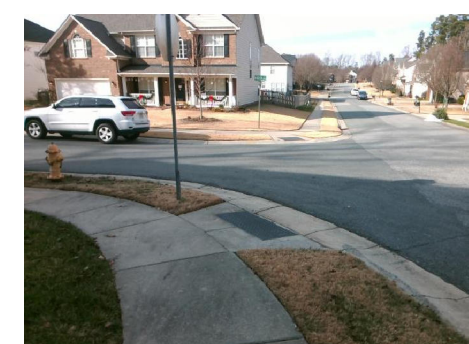
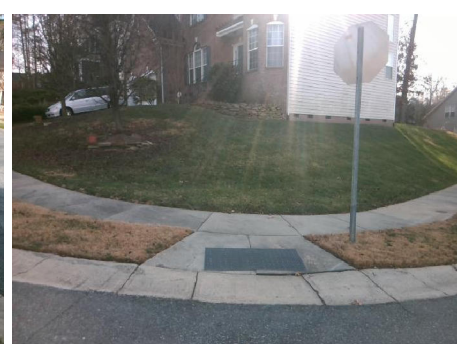
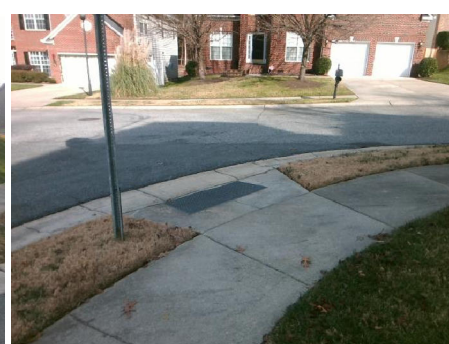
Compliance	Description	Data	Compliance	Description	Data
N/A	Ramp Length (in)	47.5	No	Ramp Slope (%)	11.2
No	Ramp Width (in)	46.5	Yes	Ramp XSlope (%)	1.4
N/A	Flare Type LT	N/A	N/A	Flare Type RT	N/A
N/A	Flare Slope LT (%)	N/A	N/A	Flare Slope RT (%)	N/A
N/A	Flare Traversable LT?	N/A	N/A	Flare Traversable RT?	N/A
N/A	Landing Length (in)	N/A	N/A	DWS Provided?	N/A
N/A	Landing Width (in)	N/A	N/A	DWS Contrast?	N/A
N/A	Landing Slope (%)	N/A	N/A	DWS Length (in)	N/A
N/A	Landing X Slope (%)	N/A	N/A	DWS Full Width?	N/A
N/A	Landing Curb? (Y/N)	N/A	N/A	DWS Offset (in)	N/A
N/A	Shared Landing?	N/A			
N/A	Gutter Ponding?	N/A	N/A	Gutter Slope (%)	N/A
N/A	Gutter Lip Ht (in)	N/A	N/A	Gutter X Slope (%)	N/A
N/A	Painted X Walk1?	No	N/A	Painted X Walk2?	No
	X Walk 1 Direction	To NE		X Walk 2 Direction	To NW
N/A	X Walk 1 Width (in)	N/A	N/A	X Walk 2 Width (in)	N/A
	X Walk 1 Slope (%)	0.1		X Walk 2 Slope (%)	4.9
	X Walk 1 X Slope (%)	3.8		X Walk 2 X Slope (%)	3.0

N/A	Ramp inside XWalk1?	N/A	N/A	Ramp inside XWalk2?	N/A
	Road Slope (%)	4.8	N/A	Clear Space?	N/A
	Road X Slope (%)	0.2	N/A	Clear Space to XWalk (in)	N/A
N/A	Any Obstructions?	N/A	N/A	Storm Grate/Utility Hazard?	N/A
	Obstruction Type			Storm Grate/Utility Type	
		N/A			N/A
			Yes	Surface Condition? (G/P)	Good

Remove & Replace Curb Ramp With Two New Directional Ramps or Equivalent.

R304.5.1, R304.2.2
