# Access Compliance Report

## Public Rights-of-Way

### (Curb Ramps)

Intersection ID: 30454	Main Street: SHALOM_PARK_DR	Cross Street: PROVIDENCE_RD	Location: NE
ADA ID: BC58698A79EB	Ramp Type: Directional1	Initial Pass/Fail: Fail	Overall Compliance: No
		Severity Score: 12.5

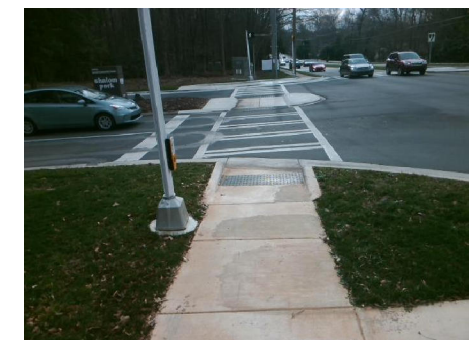
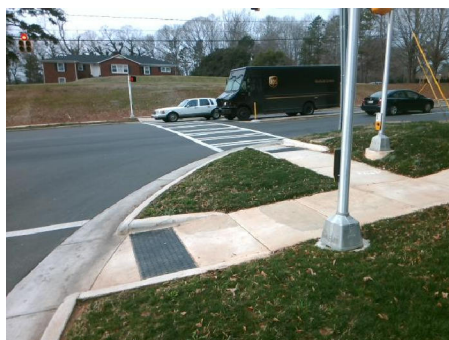
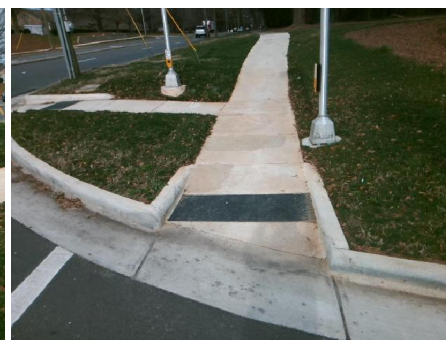
Compliance	Description	Data	Compliance	Description	Data
N/A	Ramp Length (in)	153.0	N/A	Grade Break?	N/A
Yes	Ramp Width (in)	57.0	N/A	Grade Break Slope (%)	0.0
No	Ramp Slope (%)	8.7	N/A	Grade Break XSlope (%)	0.0
Yes	Ramp XSlope (%)	1.9			
N/A	Flare Type LT	N/A	N/A	Flare Type RT	N/A
N/A	Flare Slope LT (%)	N/A	N/A	Flare Slope RT (%)	0.0
N/A	Flare Traversable LT?	N/A	N/A	Flare Traversable RT?	N/A
N/A	Landing Length (in)	0.0	N/A	DWS Provided?	N/A
N/A	Landing Width (in)	0.0	N/A	DWS Contrast?	N/A
N/A	Landing Slope (%)	0.0	N/A	DWS Length (in)	N/A
N/A	Landing X Slope (%)	0.0	N/A	DWS Full Width?	N/A
N/A	Landing Curb? (Y/N)	N/A	N/A	DWS Offset LT (in)	N/A
N/A	Shared Landing?	N/A	N/A	DWS Offset RT (in)	N/A
N/A	Gutter Ponding?	0.0	N/A	Gutter Slope (%)	N/A
N/A	Gutter Lip Ht (in)	0.0	N/A	Gutter X Slope (%)	N/A
N/A	Painted X Walk1?	Yes		Road Slope (%)	2.0
	X Walk 1 Direction	To SE		Road X Slope (%)	3.5
	X Walk 1 Width (in)	110.0		Clear Space?	N/A

X Walk 1 Slope (%)	2.0	N/A	Clear Space to XWalk (in)	N/A
	X Walk 1 X Slope (%)	3.5	N/A	Storm Grate/Utility Hazard?	N/A
N/A	Ramp inside XWalk1?	Yes		Storm Grate/Utility Type	
N/A	Any Obstructions?	N/A			N/A
	Obstruction Type		Yes	Surface Condition? (G/P)	Good
			N/A	Curb Slope (%)	2.7

**Remove & Replace Entire Ramp.**

**R304.2.2**
