# Access Compliance Report

## Public Rights-of-Way

| Intersection ID: 48568 | Main Street: BRAMBLE RIDGE CT | Cross Street: SALAMANDER RUN LN | Location: SE |
| ADA ID: BC5E1C02250C | Ramp Type: BlendTrans1 | Initial Pass/Fail: Pass | Overall Compliance: No |

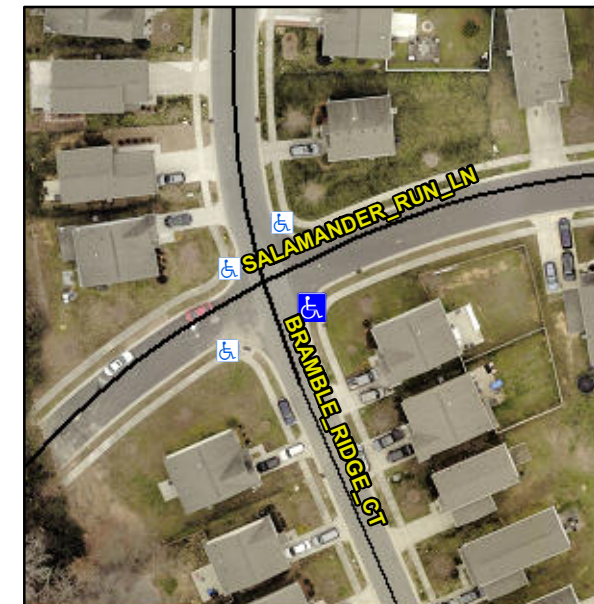
| Severity Score: 7.75 | | | |

**Not Found, R304.5.3, R304.2.2-Perp, R304.3.2-Para, R305.2, R302.7.2**

| Compliance | Description | Data | Compliance | Description | Data |
|---|---|---|---|---|---|
| Yes | Ramp Width (in) | 48.0 | No | BlendTrans XSlope (%) | 3.0 |
| No | Landing Slope (%) | 3.8 | Yes | DWS Length (in) | 24.5 |
| No | Landing X Slope (%) | 3.0 | Yes | DWS Full Width? | Yes |
| N/A | Landing Curb? (Y/N) | No | No | DWS Offset (in) | 3.0 |
| No | Gutter Lip Ht (in) | 0.3 | No | Gutter X Slope (%) | 3.7 |

**Remove & Replace Curb Ramp With Two New Directional Ramps or Equivalent. Remove & Replace Gutter.**
