# Access Compliance Report

## Public Rights-of-Way

### (Curb Ramps)

| Intersection ID: 30298 | Main Street: CHALLENGER_DR | Cross Street: METROLINER_CT | Location: E |

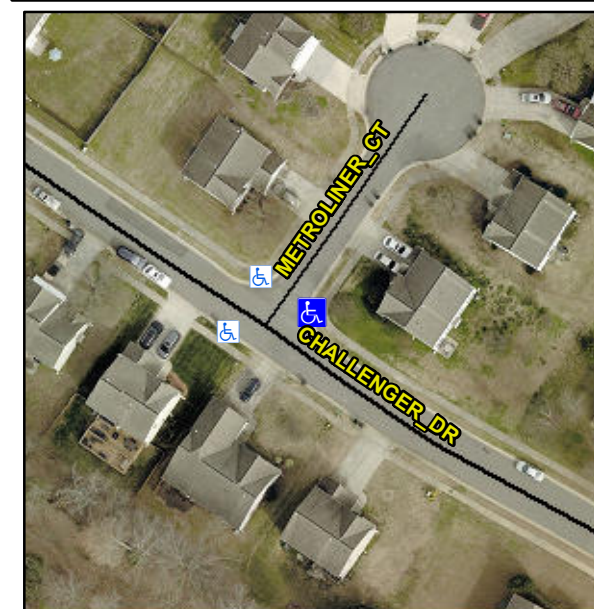
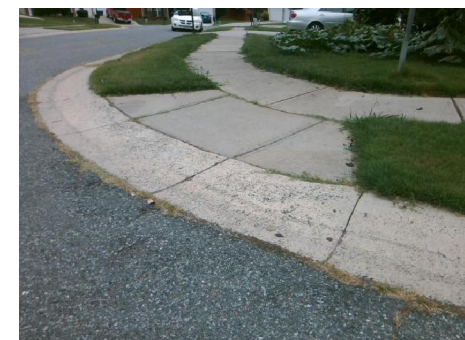
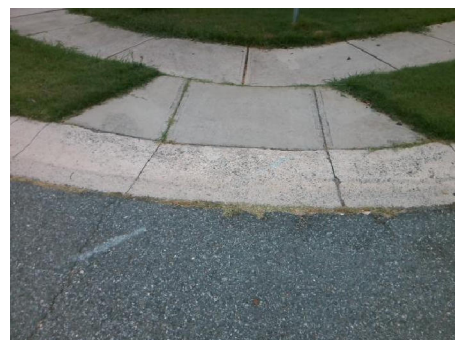
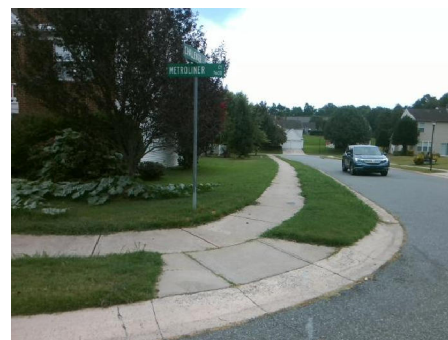
| ADA ID: BC5FC2250A13 | Ramp Type: BlendTrans1 | Initial Pass/Fail: Pass | Overall Compliance: No |

| Codes/Mitigation Info/Possible Solution | | | Severity Score: 15 |

**Not Found, R304.2.2-Perp, R304.3.2-Para, R305, R304.5.4**

| Compliance | Description | Data | Compliance | Description | Data |
|---|---|---|---|---|---|
| Yes | Landing Length (in) | 49.0 | No | DWS Provided? | No |
| No | Landing Slope (%) | 2.3 | N/A | DWS Length (in) | N/A |
| Yes | Gutter Ponding? | No | No | Gutter Slope (%) | 10.7 |
| | | | No | Curb Slope (%) | 10.7 |

**Remove & Replace Curb Ramp With Two New Directional Ramps or Equivalent. Remove & Replace Gutter.**
