# Access Compliance Report

## Public Rights-of-Way

### (Curb Ramps)

Intersection ID: 23200	Main Street: MORROWICK_RD	Cross Street: RILEY'S RIDGE_RD	Location:	N
ADA ID: BC73C5DC5884	Ramp Type: PerpDiag	Initial Pass/Fail: Fail	Overall Compliance: No	Severity Score: 22.5

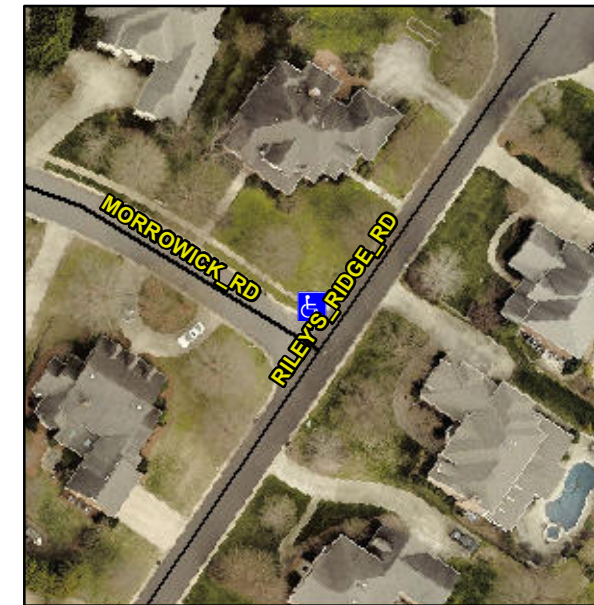
**Not Found, R304.5.1, R304.2.2, R304.5.3**

Compliance	Description	Data	Compliance	Description	Data
N/A	Ramp Length (in)	51.0	No	Ramp Slope (%)	8.7
No	Ramp Width (in)	36.0	No	Ramp XSlope (%)	4.2
N/A	Flare Type LT	N/A	N/A	Flare Type RT	N/A
N/A	Flare Slope LT (%)	N/A	N/A	Flare Slope RT (%)	N/A
N/A	Flare Traversable LT?	N/A	N/A	Flare Traversable RT?	N/A
N/A	Landing Length (in)	N/A	N/A	DWS Provided?	N/A
N/A	Landing Width (in)	N/A	N/A	DWS Contrast?	N/A
N/A	Landing Slope (%)	N/A	N/A	DWS Length (in)	N/A
N/A	Landing X Slope (%)	N/A	N/A	DWS Full Width?	N/A
N/A	Landing Curb? (Y/N)	N/A	N/A	DWS Offset (in)	N/A
N/A	Shared Landing?	N/A			
N/A	Gutter Ponding?	N/A	N/A	Gutter Slope (%)	N/A
N/A	Gutter Lip Ht (in)	N/A	N/A	Gutter X Slope (%)	N/A
N/A	Painted X Walk1?	No	N/A	Painted X Walk2?	No
	X Walk 1 Direction	To SW		X Walk 2 Direction	To SE
N/A	X Walk 1 Width (in)	N/A	N/A	X Walk 2 Width (in)	N/A
	X Walk 1 Slope (%)	1.9		X Walk 2 Slope (%)	1.0
	X Walk 1 X Slope (%)	0.7		X Walk 2 X Slope (%)	0.9

N/A	Ramp inside XWalk1?	N/A	N/A	Ramp inside XWalk2?	N/A
	Road Slope (%)	2.2	N/A	Clear Space?	N/A
	Road X Slope (%)	0.0	N/A	Clear Space to XWalk (in)	N/A
N/A	Any Obstructions?	N/A	N/A	Storm Grate/Utility Hazard?	N/A
	Obstruction Type			Storm Grate/Utility Type	
		N/A			N/A
			Yes	Surface Condition? (G/P)	Good

**Remove & Replace Curb Ramp With Two New Directional Ramps or Equivalent.**
