Access Compliance Report

Public Rights-of-Way

(Curb Ramps)

Intersection ID: 47455	Main Street: WOOD_DUCK_CROSSING_DR	Cross Street: PINTAIL_LANDING_LN	Location: NE
ADA ID: BC75C12AF3E2	Ramp Type: Perp	Initial Pass/Fail: Fail	Overall Compliance: No
Severity Score: 21.25			
Codes/Mitigation Info/Possible Solution		Field Measurements/Component Compliance

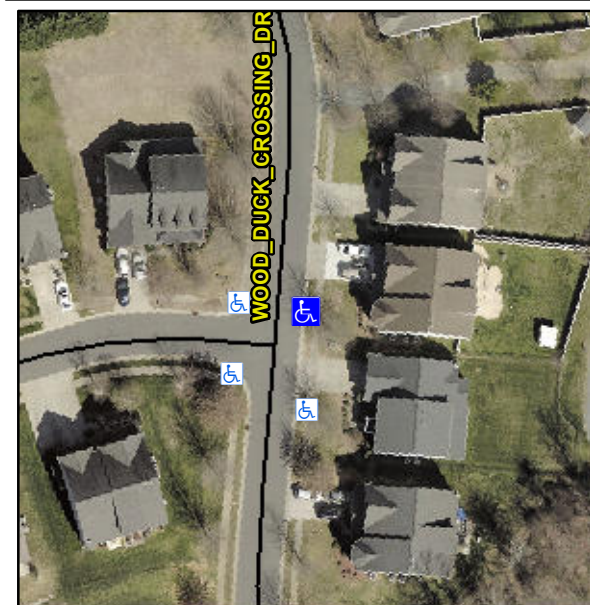
Not Found, R304.5.1, R304.2.2

Compliance	Description	Data	Compliance	Description	Data
N/A	Ramp Length (in)	48.0	No	Ramp Slope (%)	10.8
No	Ramp Width (in)	47.5	Yes	Ramp XSlope (%)	1.5
N/A	Flare Type LT	N/A	N/A	Flare Type RT	N/A
N/A	Flare Slope LT (%)	N/A	N/A	Flare Slope RT (%)	N/A
N/A	Flare Traversable LT?	N/A	N/A	Flare Traversable RT?	N/A
N/A	Landing Length (in)	N/A	N/A	DWS Provided?	N/A
N/A	Landing Width (in)	N/A	N/A	DWS Contrast?	N/A
N/A	Landing Slope (%)	N/A	N/A	DWS Length (in)	N/A
N/A	Landing X Slope (%)	N/A	N/A	DWS Full Width?	N/A
N/A	Landing Curb? (Y/N)	N/A	N/A	DWS Offset (in)	N/A
N/A	Shared Landing?	N/A			
N/A	Gutter Ponding?	N/A	N/A	Gutter Slope (%)	N/A
N/A	Gutter Lip Ht (in)	N/A	N/A	Gutter X Slope (%)	N/A
N/A	Painted X Walk1?	No	N/A	Painted X Walk2?	N/A
	X Walk 1 Direction	To NW		X Walk 2 Direction	N/A
N/A	X Walk 1 Width (in)	N/A	N/A	X Walk 2 Width (in)	N/A
	X Walk 1 Slope (%)	2.6		X Walk 2 Slope (%)	N/A
	X Walk 1 X Slope (%)	1.5		X Walk 2 X Slope (%)	N/A

N/A	Ramp inside XWalk1?	N/A	N/A	Ramp inside XWalk2?	N/A
	Road Slope (%)	N/A	N/A	Clear Space?	N/A
	Road X Slope (%)	N/A	N/A	Clear Space to XWalk (in)	N/A
N/A	Any Obstructions?	N/A	N/A	Storm Grate/Utility Hazard?	N/A
	Obstruction Type			Storm Grate/Utility Type	
		N/A			N/A
			Yes	Surface Condition? (G/P)	Good

Possible Solutions:

Remove & Replace Entire Ramp.
