# Access Compliance Report

## Public Rights-of-Way (Curb Ramps)

| Intersection ID: 17032 | Main Street: QUEENS_RD_WEST | Cross Street: WESTFIELD_RD | Location: SW |
| ADA ID: BC779B7FFA32 | Ramp Type: Directional1 | Initial Pass/Fail: Pass | Overall Compliance: No |

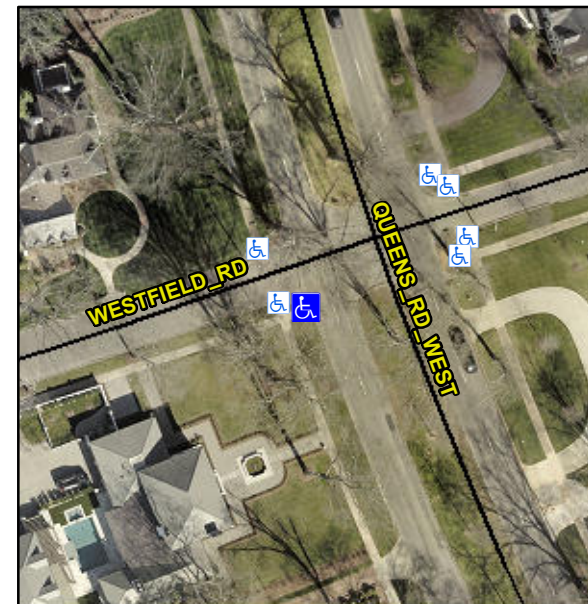
Surveyor Notes:

**NO CURB LINE, ASP LIP 2.0**

PROW/ADA:

**R304.5.3, R304.5.2, R305.2**

| Compliance | Description | Data | Compliance | Description | Data |
|---|---|---|---|---|---|
| No | Ramp XSlope (%) | 2.3 | | | |
| No | Landing X Slope (%) | 3.5 | Yes | DWS Full Width? | Yes |
| Yes | Gutter Lip Ht (in) | 0.0 | No | Gutter X Slope (%) | 2.4 |

Possible Solutions:

**Remove & Replace Entire Ramp.  
Remove & Replace Gutter.**
