Access Compliance Report Public Rights-of-Way (Curb Ramps)

Intersection ID: 9751
 Main Street: E_SUGAR_CREEK_RD
 Cross Street: NORTHMORE_ST
 Location:
 SW

ADA ID: BC7CFBC05EFF
 Ramp Type: Perp
 Initial Pass/Fail: Fail
 Overall Compliance: No
 Severity Score:
 25

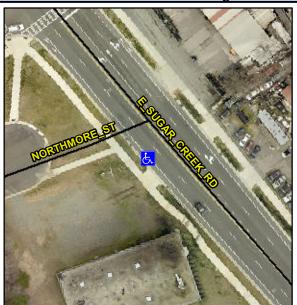
Not Found, R304.2.2

Field Measurements/Component Compliance					
Compliance Description		Data	Comp	liance Description	Data
N/A	Ramp Length (in)	25.5	No	Ramp Slope (%)	14.0
Yes	Ramp Width (in)	49.5	Yes	Ramp XSlope (%)	1.2
N/A	Flare Type LT	N/A	N/A	Flare Type RT	N/A
N/A	Flare Slope LT (%)	N/A	N/A	Flare Slope RT (%)	N/A
N/A	Flare Traversable LT?	N/A	N/A	Flare Traversable RT?	N/A
N/A	Landing Length (in)	N/A	N/A	DWS Provided?	N/A
N/A	Landing Width (in)	N/A	N/A	DWS Contrast?	N/A
N/A	Landing Slope (%)	N/A	N/A	DWS Length (in)	N/A
N/A	Landing X Slope (%)	N/A	N/A	DWS Full Width?	N/A
N/A	Landing Curb? (Y/N)	N/A	N/A	DWS Offset (in)	N/A
N/A	Shared Landing?	N/A			
N/A	Gutter Ponding?	N/A	N/A	Gutter Slope (%)	N/A
N/A	Gutter Lip Ht (in)	N/A	N/A	Gutter X Slope (%)	N/A
N/A	Painted X Walk1?	No	N/A	Painted X Walk2?	N/A
	X Walk 1 Direction	To E		X Walk 2 Direction	N/A
N/A	X Walk 1 Width (in)	N/A	N/A	X Walk 2 Width (in)	N/A
	X Walk 1 Slope (%)	3.0		X Walk 2 Slope (%)	N/A

Remove & Replace Entire Ramp.
