Access Compliance Report

Public Rights-of-Way

(Curb Ramps)

Intersection ID: 15502	Main Street: YORKMONT_RD	Cross Street: WEST_BV	Location: NE
ADA ID: BC7E8D1643D5	Ramp Type: PerpDiag	Initial Pass/Fail: Fail	Overall Compliance: No
		Severity Score: 12.5

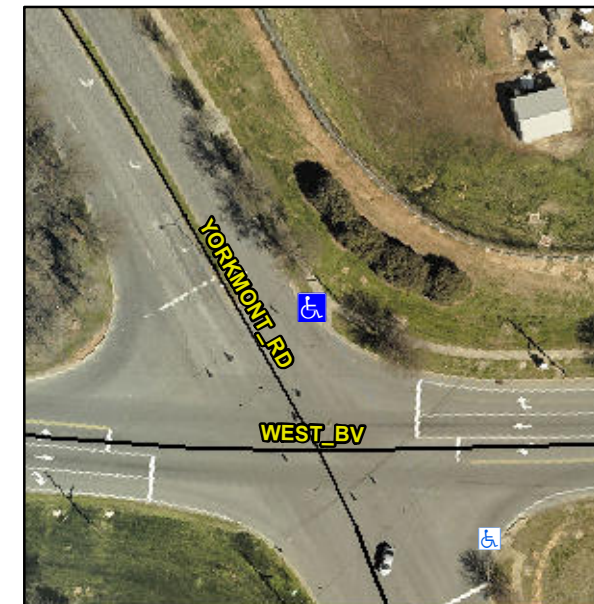
Not Found, R304.2.2

Compliance	Description	Data	Compliance	Description	Data
N/A	Ramp Length (in)	70.0	No	Ramp Slope (%)	8.8
Yes	Ramp Width (in)	48.0	Yes	Ramp XSlope (%)	1.8
N/A	Flare Type LT	N/A	N/A	Flare Type RT	N/A
N/A	Flare Slope LT (%)	N/A	N/A	Flare Slope RT (%)	N/A
N/A	Flare Traversable LT?	N/A	N/A	Flare Traversable RT?	N/A
N/A	Landing Length (in)	N/A	N/A	DWS Provided?	N/A
N/A	Landing Width (in)	N/A	N/A	DWS Contrast?	N/A
N/A	Landing Slope (%)	N/A	N/A	DWS Length (in)	N/A
N/A	Landing X Slope (%)	N/A	N/A	DWS Full Width?	N/A
N/A	Landing Curb? (Y/N)	N/A	N/A	DWS Offset (in)	N/A
N/A	Shared Landing?	N/A			
N/A	Gutter Ponding?	N/A	N/A	Gutter Slope (%)	N/A
N/A	Gutter Lip Ht (in)	N/A	N/A	Gutter X Slope (%)	N/A
N/A	Painted X Walk1?	No	N/A	Painted X Walk2?	No
	X Walk 1 Direction	To W		X Walk 2 Direction	To SE
N/A	X Walk 1 Width (in)	N/A	N/A	X Walk 2 Width (in)	N/A
	X Walk 1 Slope (%)	3.9		X Walk 2 Slope (%)	3.4
	X Walk 1 X Slope (%)	4.4		X Walk 2 X Slope (%)	2.9

N/A	Ramp inside XWalk1?	N/A	N/A	Ramp inside XWalk2?	N/A
	Road Slope (%)	1.6	N/A	Clear Space?	N/A
	Road X Slope (%)	3.4	N/A	Clear Space to XWalk (in)	N/A
N/A	Any Obstructions?	N/A	N/A	Storm Grate/Utility Hazard?	N/A
	Obstruction Type			Storm Grate/Utility Type	
		N/A			N/A
			Yes	Surface Condition? (G/P)	Good

Remove & Replace Curb Ramp With Two New Directional Ramps or Equivalent.

Total Cost: \$ 3200.00
