# Access Compliance Report

## Public Rights-of-Way

### (Curb Ramps)

Intersection ID: 10023986	Main Street: COPPER_WY	Cross Street: N/A	Location: NE
ADA ID: BC845B6B3EAD	Ramp Type: BlendTrans1	Initial Pass/Fail: Fail	Overall Compliance: No
		Severity Score: 8.75

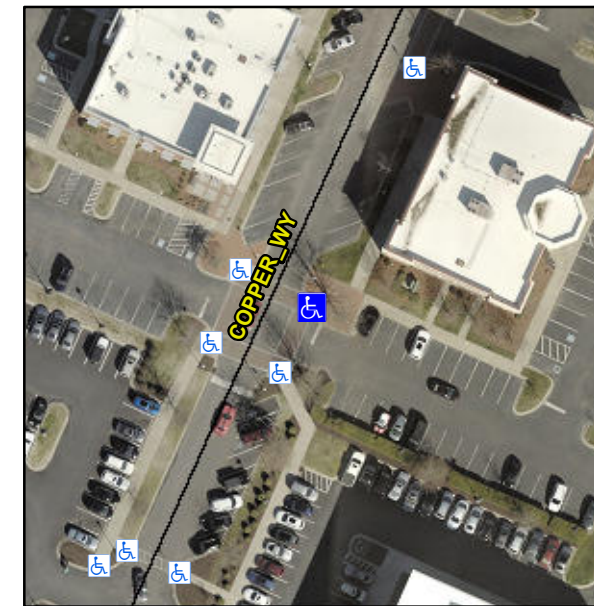
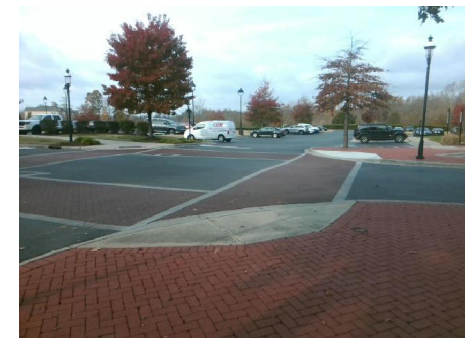
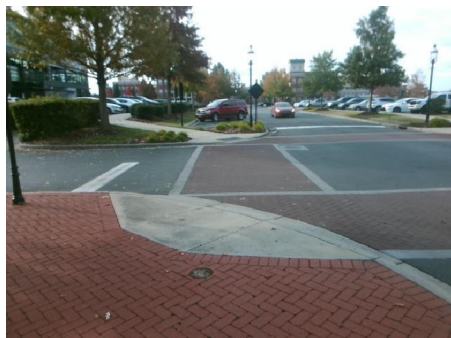
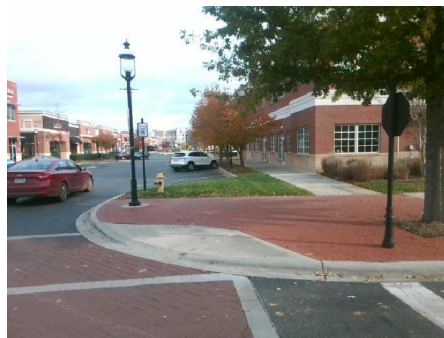
**Not Found, R304.5.1**

Compliance	Description	Data	Compliance	Description	Data
N/A	Ramp Length (in)	58.5	Yes	BlendTrans Slope (%)	2.8
No	Ramp Width (in)	46.0	Yes	BlendTrans XSlope (%)	0.3
N/A	Flare Type LT	N/A	N/A	Flare Type RT	N/A
N/A	Flare Slope LT (%)	N/A	N/A	Flare Slope RT (%)	N/A
N/A	Flare Traversable LT?	N/A	N/A	Flare Traversable RT?	N/A
N/A	Landing Length (in)	N/A	N/A	DWS Provided?	N/A
N/A	Landing Width (in)	N/A	N/A	DWS Contrast?	N/A
N/A	Landing Slope (%)	N/A	N/A	DWS Length (in)	N/A
N/A	Landing X Slope (%)	N/A	N/A	DWS Full Width?	N/A
N/A	Landing Curb? (Y/N)	N/A	N/A	DWS Offset (in)	N/A
N/A	Shared Landing?	N/A			
N/A	Gutter Ponding?	N/A	N/A	Gutter Slope (%)	N/A
N/A	Gutter Lip Ht (in)	N/A	N/A	Gutter X Slope (%)	N/A
N/A	Painted X Walk1?	Yes	N/A	Painted X Walk2?	Yes
	X Walk 1 Direction	To NW		X Walk 2 Direction	To SW
	X Walk 1 Width (in)	101.0		X Walk 2 Width (in)	109.0
	X Walk 1 Slope (%)	1.8		X Walk 2 Slope (%)	1.3
	X Walk 1 X Slope (%)	2.7		X Walk 2 X Slope (%)	0.3

N/A	Ramp inside XWalk1?	Yes	N/A	Ramp inside XWalk2?	Yes
	Road Slope (%)	0.3		Clear Space?	N/A
	Road X Slope (%)	2.0	N/A	Clear Space to XWalk (in)	N/A
N/A	Any Obstructions?	N/A	N/A	Storm Grate/Utility Hazard?	N/A
	Obstruction Type			Storm Grate/Utility Type	
		N/A			N/A
			Yes	Surface Condition? (G/P)	Good
			No	Curb Slope (%)	18.2

**Remove & Replace Curb Ramp With Two New Directional Ramps or Equivalent.**
