# Access Compliance Report

## Public Rights-of-Way

### (Curb Ramps)

Intersection ID: N/A	Main Street: COSTIGAN_LN	Cross Street: N/A	Location: SE
ADA ID: BC861CBC0CA4	Ramp Type: PerpDiag	Initial Pass/Fail: Fail	Overall Compliance: No
Severity Score: 33.75			
Codes/Mitigation Info/Possible Solution		Field Measurements/Component Compliance

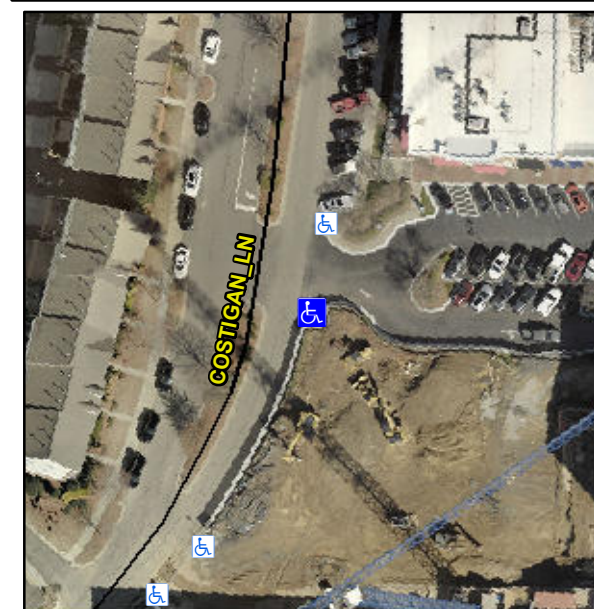
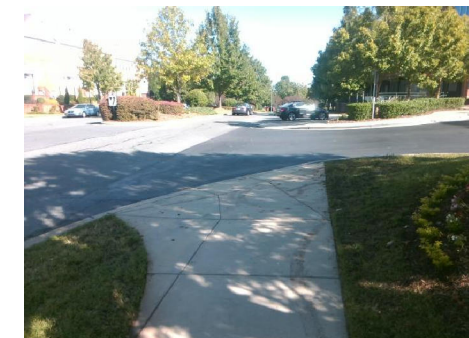
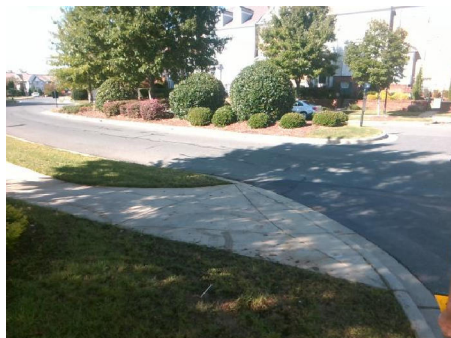
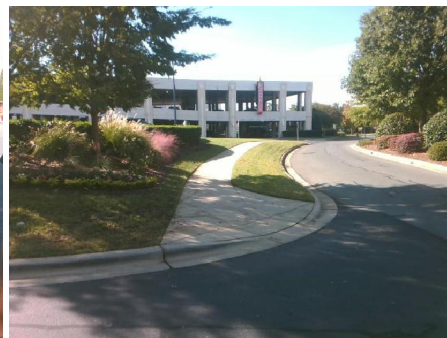
**Not Found, R304.5.1, R304.5.3**

Compliance	Description	Data	Compliance	Description	Data
N/A	Ramp Length (in)	93.0	Yes	Ramp Slope (%)	5.5
No	Ramp Width (in)	45.0	No	Ramp XSlope (%)	7.0
N/A	Flare Type LT	N/A	N/A	Flare Type RT	N/A
N/A	Flare Slope LT (%)	N/A	N/A	Flare Slope RT (%)	N/A
N/A	Flare Traversable LT?	N/A	N/A	Flare Traversable RT?	N/A
N/A	Landing Length (in)	N/A	N/A	DWS Provided?	N/A
N/A	Landing Width (in)	N/A	N/A	DWS Contrast?	N/A
N/A	Landing Slope (%)	N/A	N/A	DWS Length (in)	N/A
N/A	Landing X Slope (%)	N/A	N/A	DWS Full Width?	N/A
N/A	Landing Curb? (Y/N)	N/A	N/A	DWS Offset (in)	N/A
N/A	Shared Landing?	N/A			
N/A	Gutter Ponding?	N/A	N/A	Gutter Slope (%)	N/A
N/A	Gutter Lip Ht (in)	N/A	N/A	Gutter X Slope (%)	N/A
N/A	Painted X Walk1?	No	N/A	Painted X Walk2?	No
	X Walk 1 Direction	To N		X Walk 2 Direction	To W
N/A	X Walk 1 Width (in)	N/A	N/A	X Walk 2 Width (in)	N/A
	X Walk 1 Slope (%)	0.1		X Walk 2 Slope (%)	0.2
	X Walk 1 X Slope (%)	5.8		X Walk 2 X Slope (%)	2.2

N/A	Ramp inside XWalk1?	N/A	N/A	Ramp inside XWalk2?	N/A
	Road Slope (%)	6.0	N/A	Clear Space?	N/A
	Road X Slope (%)	1.5	N/A	Clear Space to XWalk (in)	N/A
N/A	Any Obstructions?	N/A	N/A	Storm Grate/Utility Hazard?	N/A
	Obstruction Type			Storm Grate/Utility Type	
		N/A			N/A
			Yes	Surface Condition? (G/P)	Good

**Remove & Replace Curb Ramp With Two New Directional Ramps or Equivalent.**
