Access Compliance Report

Public Rights-of-Way

(Curb Ramps)

Intersection ID: 43492	Main Street: CHESLEY_DR	Cross Street: REDWOOD_VALLEY_LN	Location: NW
ADA ID: BC87E519DB83	Ramp Type: PerpDiag	Initial Pass/Fail: Fail	Overall Compliance: No
		Severity Score: 10

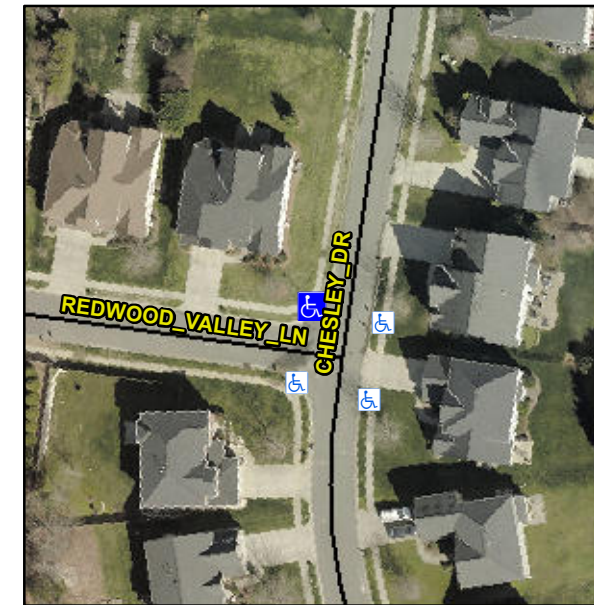
Compliance	Description	Data	Compliance	Description	Data
N/A	Ramp Length (in)	45.0	Yes	Ramp Slope (%)	8.2
No	Ramp Width (in)	47.0	No	Ramp XSlope (%)	4.7
N/A	Flare Type LT	N/A	N/A	Flare Type RT	N/A
N/A	Flare Slope LT (%)	N/A	N/A	Flare Slope RT (%)	N/A
N/A	Flare Traversable LT?	N/A	N/A	Flare Traversable RT?	N/A
N/A	Landing Length (in)	N/A	N/A	DWS Provided?	N/A
N/A	Landing Width (in)	N/A	N/A	DWS Contrast?	N/A
N/A	Landing Slope (%)	N/A	N/A	DWS Length (in)	N/A
N/A	Landing X Slope (%)	N/A	N/A	DWS Full Width?	N/A
N/A	Landing Curb? (Y/N)	N/A	N/A	DWS Offset (in)	N/A
N/A	Shared Landing?	N/A			
N/A	Gutter Ponding?	N/A	N/A	Gutter Slope (%)	N/A
N/A	Gutter Lip Ht (in)	N/A	N/A	Gutter X Slope (%)	N/A
N/A	Painted X Walk1?	No	N/A	Painted X Walk2?	No
	X Walk 1 Direction	To SW		X Walk 2 Direction	To SE
N/A	X Walk 1 Width (in)	N/A	N/A	X Walk 2 Width (in)	N/A
	X Walk 1 Slope (%)	2.9		X Walk 2 Slope (%)	2.0
	X Walk 1 X Slope (%)	0.2		X Walk 2 X Slope (%)	2.0

N/A	Ramp inside XWalk1?	N/A	N/A	Ramp inside XWalk2?	N/A
	Road Slope (%)	3.3	N/A	Clear Space?	N/A
	Road X Slope (%)	6.4	N/A	Clear Space to XWalk (in)	N/A
N/A	Any Obstructions?	N/A	N/A	Storm Grate/Utility Hazard?	N/A
	Obstruction Type			Storm Grate/Utility Type	
		N/A			N/A
			Yes	Surface Condition? (G/P)	Good

Remove & Replace Curb Ramp With Two New Directional Ramps or Equivalent.

Not Found, R304.5.1, R304.5.3
