# Access Compliance Report

## Public Rights-of-Way

### (Curb Ramps)

Intersection ID: 48451	Main Street: RED_RUST_LN	Cross Street: DANCING_WIND_RD	Location: SW
ADA ID: BC93EED751FC	Ramp Type: Perp	Initial Pass/Fail: Fail	Overall Compliance: No
Severity Score: 21.25			
Codes/Mitigation Info/Possible Solution		Field Measurements/Component Compliance

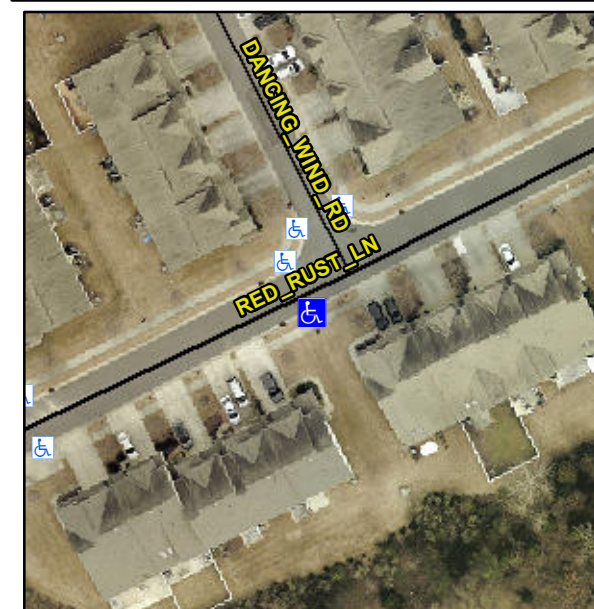
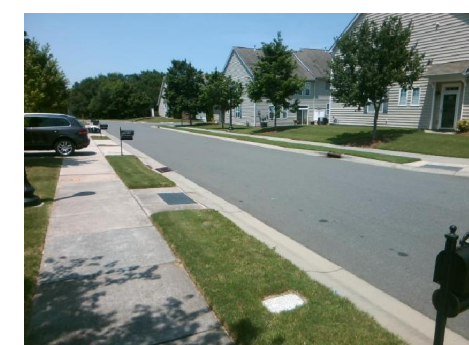
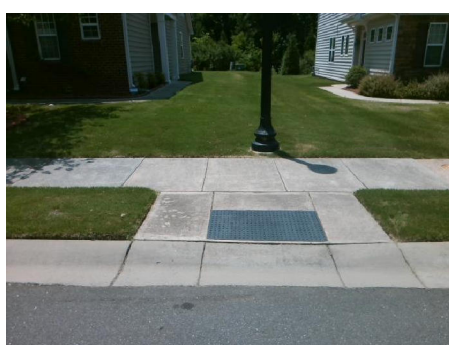
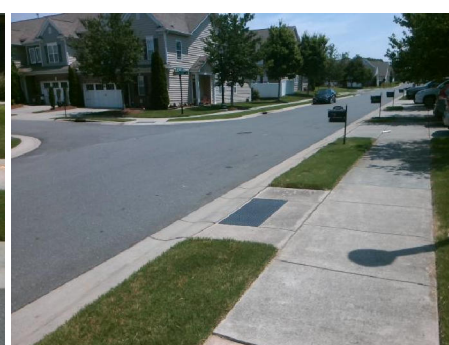
**Not Found, R304.5.1, R304.2.2**

Compliance	Description	Data	Compliance	Description	Data
N/A	Ramp Length (in)	47.0	No	Ramp Slope (%)	8.7
No	Ramp Width (in)	47.0	Yes	Ramp XSlope (%)	2.0
N/A	Flare Type LT	N/A	N/A	Flare Type RT	N/A
N/A	Flare Slope LT (%)	N/A	N/A	Flare Slope RT (%)	N/A
N/A	Flare Traversable LT?	N/A	N/A	Flare Traversable RT?	N/A
N/A	Landing Length (in)	N/A	N/A	DWS Provided?	N/A
N/A	Landing Width (in)	N/A	N/A	DWS Contrast?	N/A
N/A	Landing Slope (%)	N/A	N/A	DWS Length (in)	N/A
N/A	Landing X Slope (%)	N/A	N/A	DWS Full Width?	N/A
N/A	Landing Curb? (Y/N)	N/A	N/A	DWS Offset (in)	N/A
N/A	Shared Landing?	N/A			
N/A	Gutter Ponding?	N/A	N/A	Gutter Slope (%)	N/A
N/A	Gutter Lip Ht (in)	N/A	N/A	Gutter X Slope (%)	N/A
N/A	Painted X Walk1?	No	N/A	Painted X Walk2?	N/A
	X Walk 1 Direction	To NW		X Walk 2 Direction	N/A
N/A	X Walk 1 Width (in)	N/A	N/A	X Walk 2 Width (in)	N/A
	X Walk 1 Slope (%)	3.4		X Walk 2 Slope (%)	N/A
	X Walk 1 X Slope (%)	2.0		X Walk 2 X Slope (%)	N/A

N/A	Ramp inside XWalk1?	N/A	N/A	Ramp inside XWalk2?	N/A
	Road Slope (%)	N/A	N/A	Clear Space?	N/A
	Road X Slope (%)	N/A	N/A	Clear Space to XWalk (in)	N/A
N/A	Any Obstructions?	N/A	N/A	Storm Grate/Utility Hazard?	N/A
	Obstruction Type			Storm Grate/Utility Type	
		N/A			N/A
			Yes	Surface Condition? (G/P)	Good

**Remove & Replace Entire Ramp.**

Total Cost: \$ 1850.00
