Access Compliance Report

Public Rights-of-Way

(Curb Ramps)

Intersection ID: 52931	Main Street: WALTHAM_LN	Cross Street: GRAY_OAK_LN	Location: W
ADA ID: BC97757EDFD1	Ramp Type: Perp	Initial Pass/Fail: Pass	Overall Compliance: No
Severity Score: 0			
Codes/Mitigation Info/Possible Solution		Field Measurements/Component Compliance

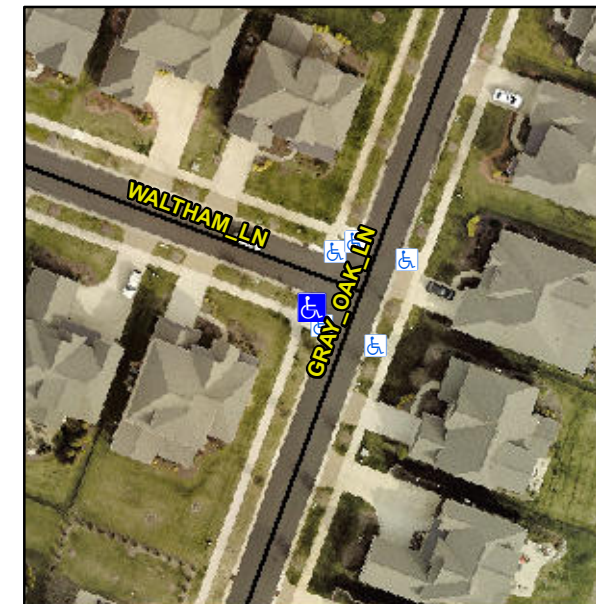
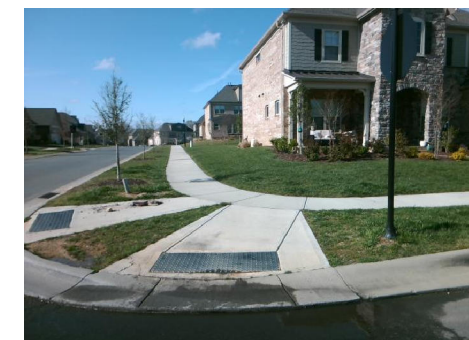
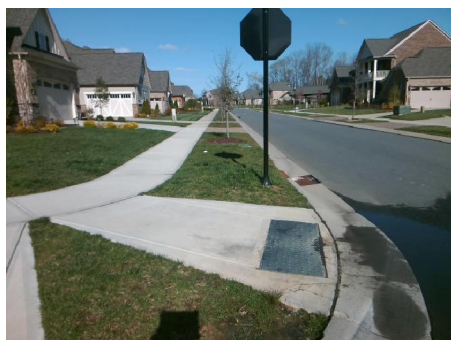
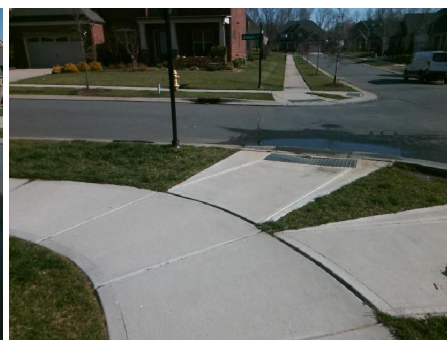
R304.5.3, R305.2

Compliance	Description	Data	Compliance	Description	Data
N/A	Ramp Length (in)	120.0	Yes	Ramp Slope (%)	7.4
Yes	Ramp Width (in)	51.0	Yes	Ramp XSlope (%)	0.9
N/A	Flare Type LT	Sloped	N/A	Flare Type RT	N/A
N/A	Flare Slope LT (%)	0.6	Yes	Flare Slope RT (%)	4.2
N/A	Flare Traversable LT?	Yes	N/A	Flare Traversable RT?	Yes
Yes	Landing Length (in)	61.0	Yes	DWS Provided?	Yes
Yes	Landing Width (in)	58.0	Yes	DWS Contrast?	Yes
Yes	Landing Slope (%)	2.0	Yes	DWS Length (in)	24.0
No	Landing X Slope (%)	2.8	Yes	DWS Full Width?	Yes
N/A	Landing Curb? (Y/N)	No	No	DWS Offset (in)	5.0
N/A	Shared Landing?	No			
Yes	Gutter Ponding?	No	Yes	Gutter Slope (%)	4.9
Yes	Gutter Lip Ht (in)	0.0	Yes	Gutter X Slope (%)	0.9
N/A	Painted X Walk1?	No	N/A	Painted X Walk2?	N/A
	X Walk 1 Direction	To NE		X Walk 2 Direction	N/A
N/A	X Walk 1 Width (in)	N/A	N/A	X Walk 2 Width (in)	N/A
	X Walk 1 Slope (%)	0.3		X Walk 2 Slope (%)	N/A
	X Walk 1 X Slope (%)	0.0		X Walk 2 X Slope (%)	N/A

N/A	Ramp inside XWalk1?	N/A	N/A	Ramp inside XWalk2?	N/A
	Road Slope (%)	N/A	N/A	Clear Space?	Yes
	Road X Slope (%)	N/A	N/A	Clear Space to XWalk (in)	N/A
Yes	Any Obstructions?	No	Yes	Storm Grate/Utility Hazard?	No
	Obstruction Type			Storm Grate/Utility Type	
		N/A			N/A
			Yes	Surface Condition? (G/P)	Good

Remove & Replace Entire Ramp.

Total Cost: \$ 1850.00
