Access Compliance Report Public Rights-of-Way (Curb Ramps)

Intersection ID: N/AMain Street:UNIVERSITY_CITY_BVCross Street: N/ALocation:NEADA ID: BC9FC1FBF340Ramp Type:Directional1Initial Pass/Fail: PassOverall Compliance: NoSeverity Score:5

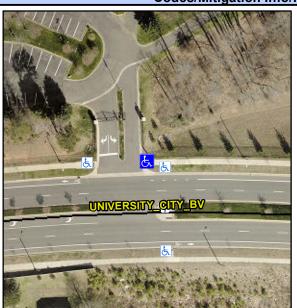
Compl	iance Description	Data		liance Description	Data
N/A	Ramp Length (in)	122.0	Yes	Grade Break?	Yes
Yes	Ramp Width (in)	71.0	Yes	Grade Break Slope (%)	1.3
Yes	Ramp Slope (%)	1.6	No	Grade Break XSlope (%)	6.2
Yes	Ramp XSlope (%)	1.7			
Yes	Flare Type LT	N/A	Yes	Flare Type RT	N/A
N/A	Flare Slope LT (%)	N/A	N/A	Flare Slope RT (%)	N/A
N/A	Flare Traversable LT?	No	N/A	Flare Traversable RT?	No
Yes	Landing Length (in)	63.0	Yes	DWS Provided?	Yes
Yes	Landing Width (in)	72.0	Yes	DWS Contrast?	Yes
No	Landing Slope (%)	4.3	Yes	DWS Length (in)	24.0
Yes	Landing X Slope (%)	1.5	Yes	DWS Full Width?	Yes
N/A	Landing Curb? (Y/N)	N/A	Yes	DWS Offset LT (in)	28.0
N/A	Shared Landing?	No	No	DWS Offset RT (in)	8.0
Yes	Gutter Ponding?	No	No	Gutter Slope (%)	8.1
Yes	Gutter Lip Ht (in)	0.0	No	Gutter X Slope (%)	6.0
N/A	Painted X Walk1?	No		Road Slope (%)	2.2
	X Walk 1 Direction	To SW		Road X Slope (%)	6.7
	X Walk 1 Width (in)	N/A		Clear Space?	Yes

X Walk 1 Slope (%)	2.2	N/A	Clear Space to XWalk (in)	N/A
	X Walk 1 X Slope (%)	6.7	Yes	Storm Grate/Utility Hazard?	No
N/A	Ramp inside XWalk1?	N/A		Storm Grate/Utility Type	
Yes	Any Obstructions?	No			N/A
	Obstruction Type		Yes	Surface Condition? (G/P)	Good
		N/A	Yes	Curb Slope (%)	7.3

Remove & Replace Entire Ramp.
Remove & Replace Gutter.
